CENTRAL TEXAS REGIONAL
MOBILITY AUTHORITY

2019 ANNUAL REPORT OF CONDITIONS

Subject: 2019 Annual Report of Conditions – 183A Turnpike, 290E Project, SH 71 Express and 183 South Interim Milestone Roadways

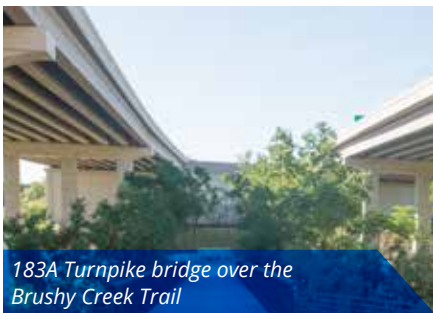
183A Turnpike bridge over the Brushy Creek Trail

Based on a review of the most recent inspection reports and visual observations, all 183A Turnpike bridges, including those for the shared use path, remain in good condition. There are no significant deficiencies noted in the 2017 NBIP Reports. The most common deficiencies noted were hairline longitudinal and transverse cracks, loss of adhesion and missing sealant at bridge joints, sediment build-up in bridge deck drains and channel erosion.
