**183A Turnpike**  
**2012 Annual Inspection**  
**Detailed Inspection Report**

**183A Turnpike  
2012 Annual Inspection  
Detailed Inspection Report**

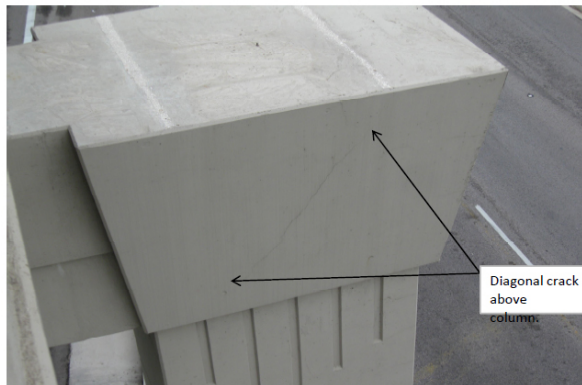
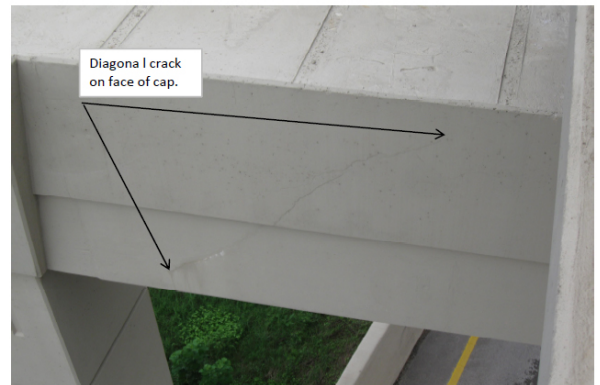
### Bridge Number (23): 14-246-T001-83-003

- Bent #3 cracks on columns and cap
- The columns are 5'x7.5'. Based on the results of an engineering review performed by PE Structural Consultants, Inc, there is adequate shear and flexural reinforcing, and the structure is sound.

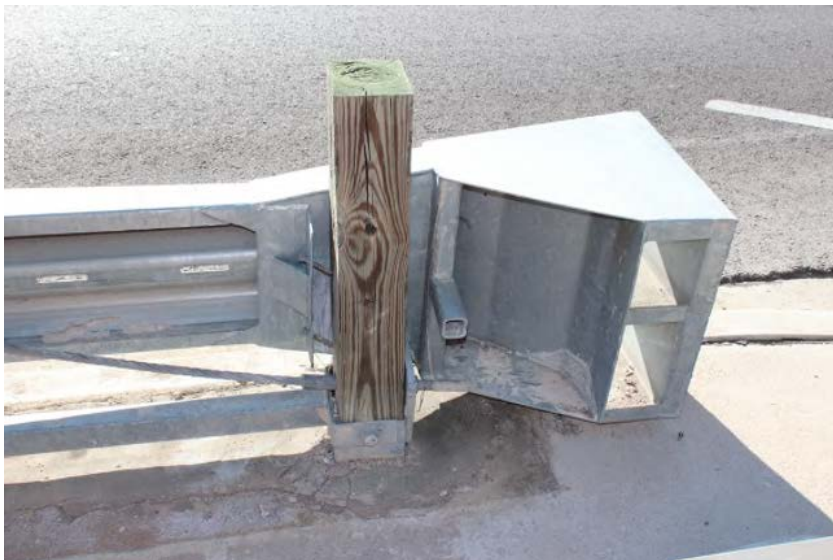
### Bridge Number (7): 14-246-T001-83-015

- Metal beam guard fence approach terminal detached in NE corner. This condition should be scheduled for corrective work.

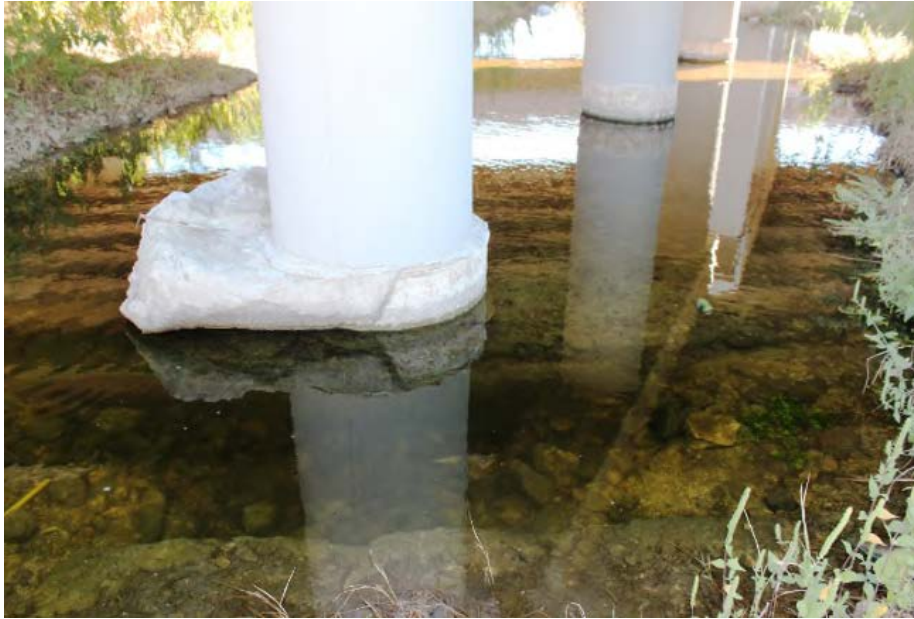
- Scour has exposed drill shafts at bent 2, up to 4 ft. depth. Based on a review of the record plans and soil boring logs, this scour does not compromise the structural integrity of the bent since the remaining soil provides adequate skin friction for the shafts. No corrective work is warranted at this time. However, this area should be monitored.

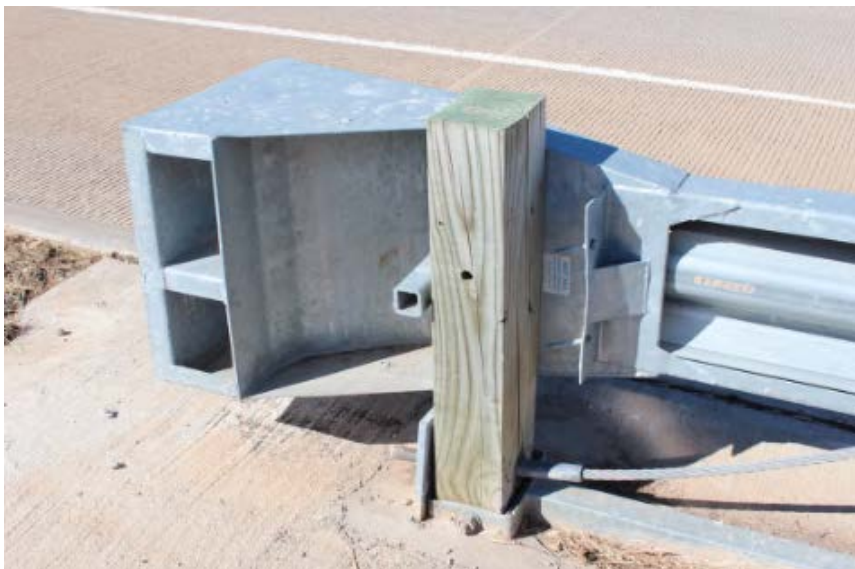
**Bridge Number (6): 14-246-T001-83-016**

- Metal beam guard fence approach terminal detached in SE corner. This condition should be scheduled for corrective work.
