**Re: 2014 Annual Report of Conditions – 183A Turnpike / Manor Expressway**

**2014 Annual Report of Conditions**  
**183A Turnpike – HNTB**  
**Manor Expressway - Atkins**

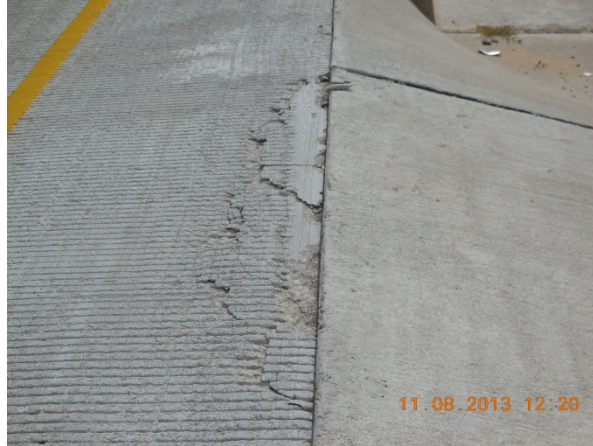
No major roadway deficiencies have been identified during the 2013 visual inspection period that would negatively affect current safety and operations of the facility. Based on the 2013 Fall visual inspection, the concrete pavement sections of the 183A Turnpike mainlanes remain in good condition. There was only one defect observed during inspection; some large spalls are developing on the West edge of the northbound entrance ramp just north of New Hope Drive. Since this area is on the edge of the roadway and does not carry traffic, this area should be monitored during 2014-2015 if it is not repaired.

Concrete pavement spalling at northbound entrance ramp just north of New Hope Drive

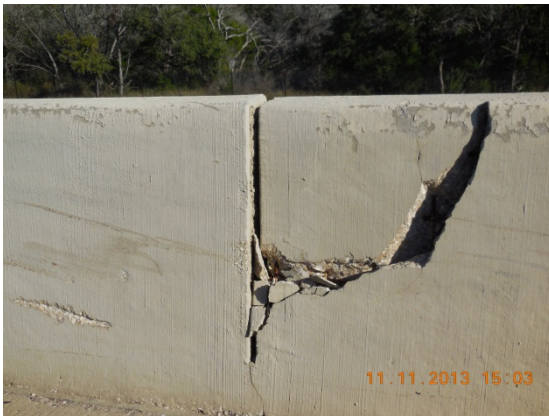
Northbound mainlane north of  
Avery Ranch Boulevard

There are a few isolated sections of Single Slope Traffic Rail (SSTR) along the northbound mainlanes of the 183A Turnpike that are significantly cracked or damaged and, though they do not negatively affect the safety or functionality of the facility, they are unsightly and should be repaired within the next year. Some examples are shown below.

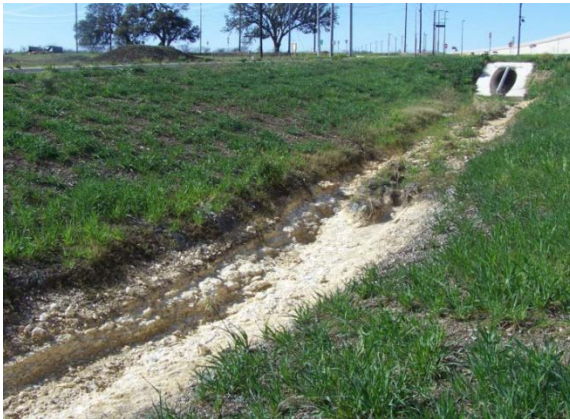
Observed channel erosion

In cases of channel erosion where a rock bottom is not evident, it is recommended that the channel be re-graded and lined with erosion control matting until adequate vegetation can be established.

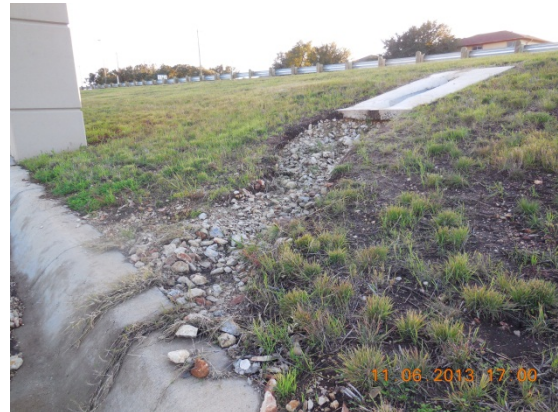
Above retaining wall 20, there is a gap between a storm sewer outfall and the retaining wall flume. The soil is eroded in this area. It is recommended that concrete rip rap be placed to direct flow from the outfall to the flume.

Erosion above retaining wall 20

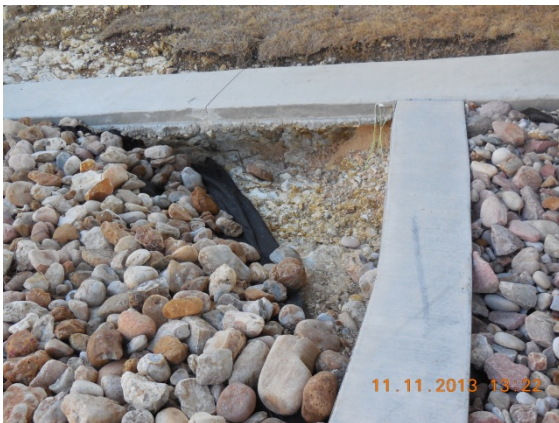
Erosion of decorative rock at the north end of the South Brushy Creek Pedestrian Bridge

At the north end of the South Brushy Creek Pedestrian Bridge, the concrete mow strip has been undermined by erosion, resulting in a washing away of decorative rocks. This is believed to have been the result of an inlet being clogged across the street and excess flow crossing the street and eroding the landscaping areas. At this time, the inlet has been cleaned and should be kept clear through regular maintenance activities. The eroded area should be reconstructed and monitored to assure no further issues develop.

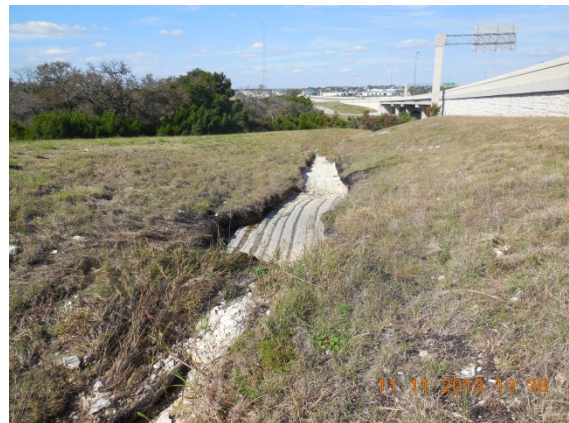
Erosion in channel along southbound mainline south of South Brushy Creek

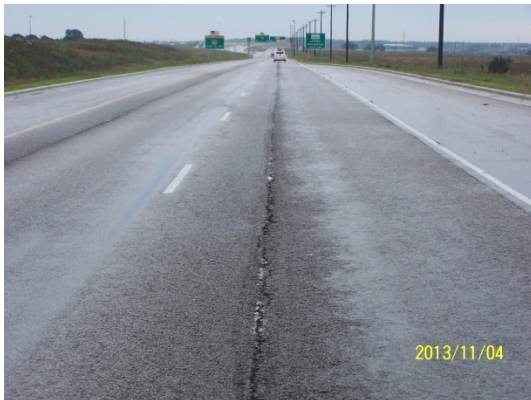
**Pavement Condition, Striping and Markings** – During the 2013 Fall inspection period, the primary deficiency identified was longitudinal and fatigue cracking along the asphalt paved frontage roads between RM 1431 north to the intersection with US 183. Below are some examples of areas from the inspection.

Observed longitudinal cracking

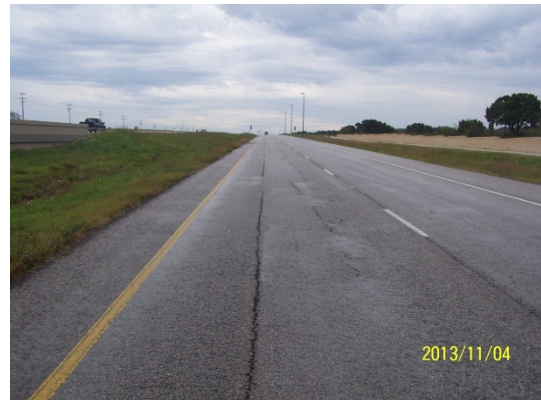
Observed longitudinal cracking

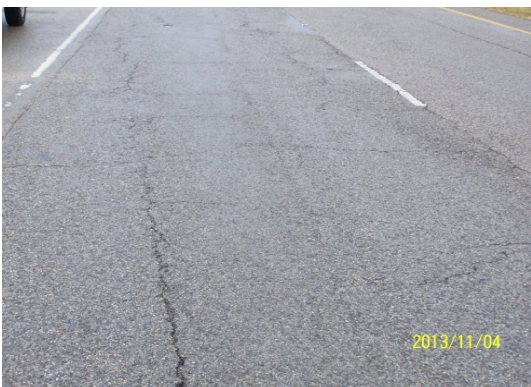
Observed fatigue cracking

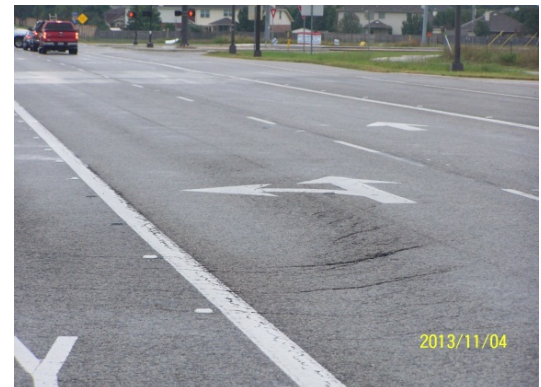
Observed fatigue cracking

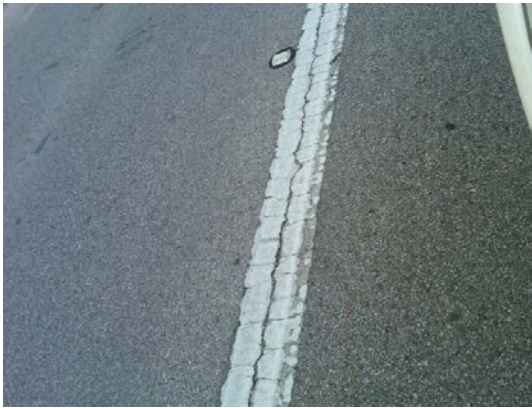
The striping along the northbound and southbound frontage road is in fair condition. The pavement markings are visible but are experiencing fading and cracking along a majority of both the northbound and southbound frontage roads. The highest concentration of fading occurs at the approaches to each intersection with cracking occurring throughout.

Observed pavement marking cracking

The markings along the mainlanes are in good condition with some fading, but isolated primarily at the ramp gores. As a maintenance measure, the striping should be replaced in these areas. Any substandard striping will be addressed under the Performance Based Maintenance Contract ILA with TxDOT.

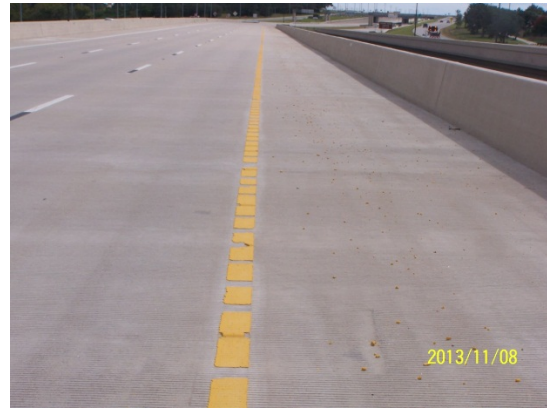
Observed pavement marking fading

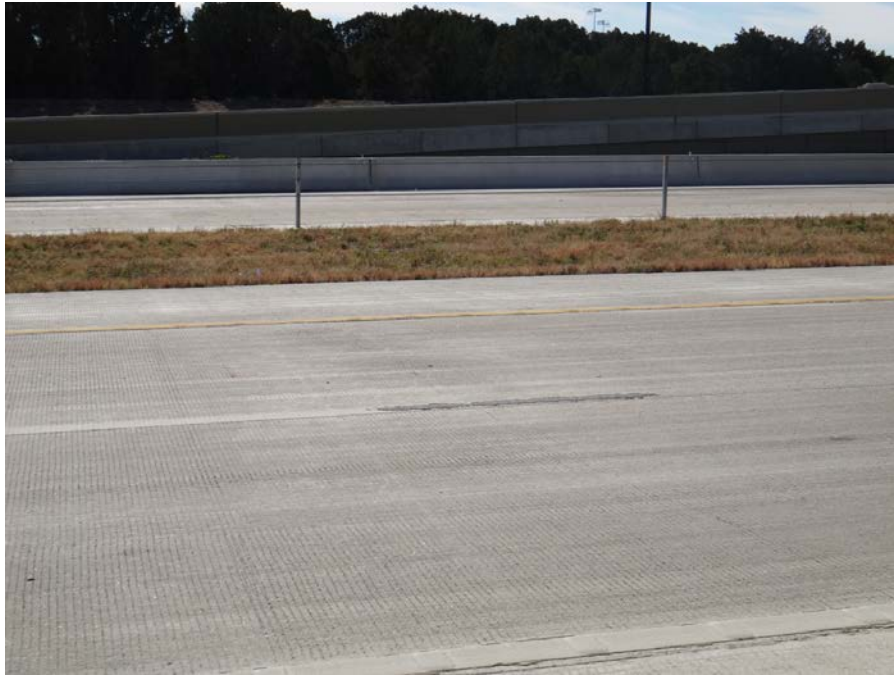
**Pavement Striping and Markings**– The pavement striping along the facility is visible; however, the original blacktail skip striping is experiencing fading along a majority of the corridor and should be replaced in these areas. Another deficiency that warrants attention is striping that is faded along the westbound entrance ramp. A list of deficiencies have been provided to the Mobility Authority to be addressed.

Faded black tail skip stripe

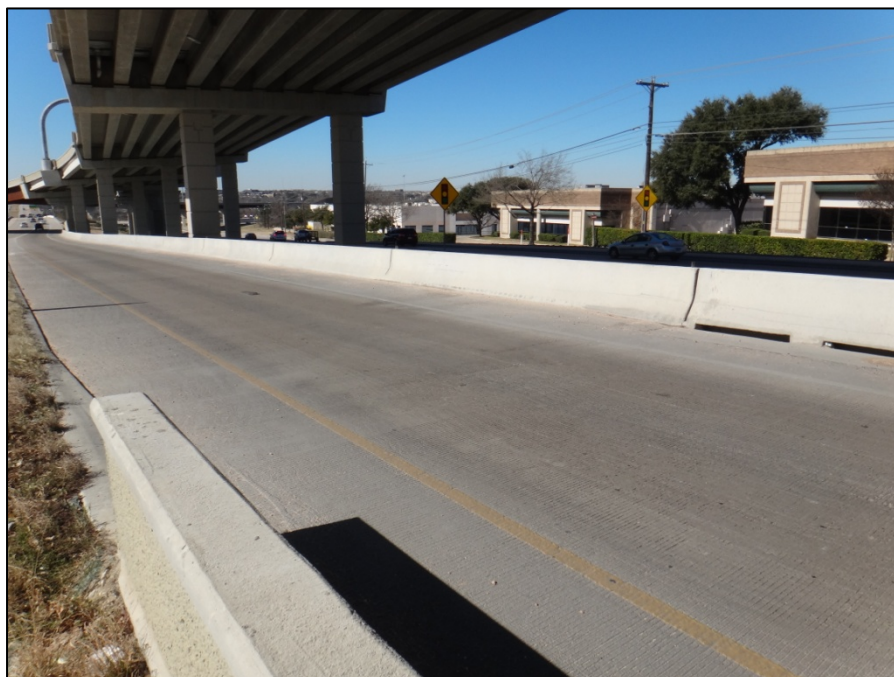
Faded white striping along westbound entrance ramp
