CENTRAL TEXAS REGIONAL  
MOBILITY AUTHORITY

# 2019 ANNUAL REPORT OF CONDITIONS

**Subject: 2019 Annual Report of Conditions – 183A Turnpike, 290E Project, SH 71 Express and 183 South Interim Milestone Roadways**

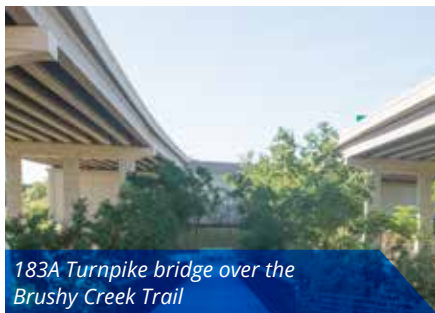
183A Turnpike bridge over the Brushy Creek Trail

Based on a review of the most recent inspection reports and visual observations, all 183A Turnpike bridges, including those for the shared use path, remain in good condition. There are no significant deficiencies noted in the 2017 NBIP Reports. The most common deficiencies noted were hairline longitudinal and transverse cracks, loss of adhesion and missing sealant at bridge joints, sediment build-up in bridge deck drains and channel erosion.

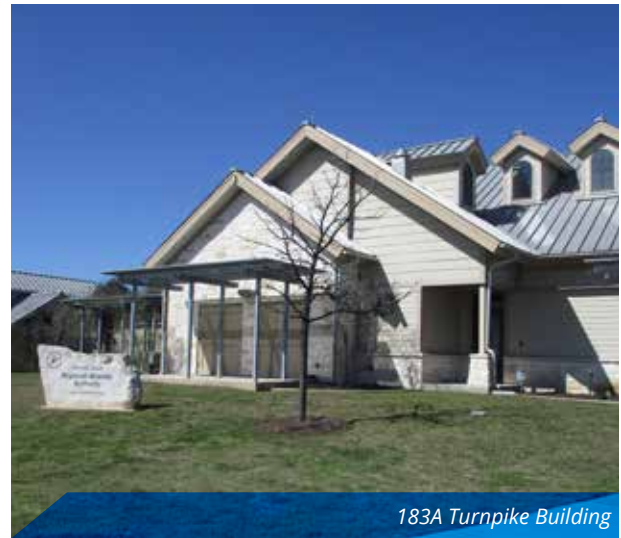
183A Turnpike Building

All fire protection equipment appeared to be in good working order. Fire suppression systems will be inspected by a licensed professional as there are no panels available to check the status of the system.

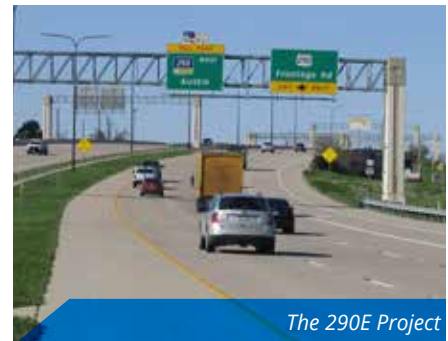
Transverse cracking was observed at several locations along the corridor. This issue does not require immediate attention; however, it should continue to be monitored during future condition inspections.

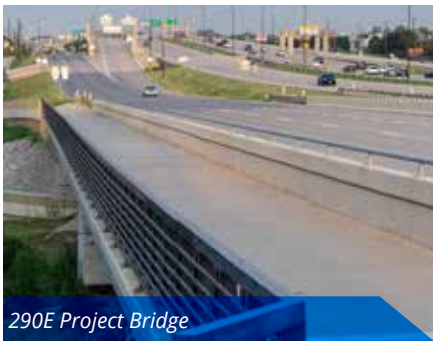
290E Project Bridge

Based on a review of the most recent inspection reports and visual observations, 290E Project bridges are in adequate or better condition. The most common deficiencies notes were channel erosion and hairline cracking of bridge components.
