March 31, 2016

Re: 2016 Annual Report of Conditions – 183A Turnpike / Manor Expressway

2016 Annual Report of Conditions
183A Turnpike – HNTB
Manor Expressway - Atkins

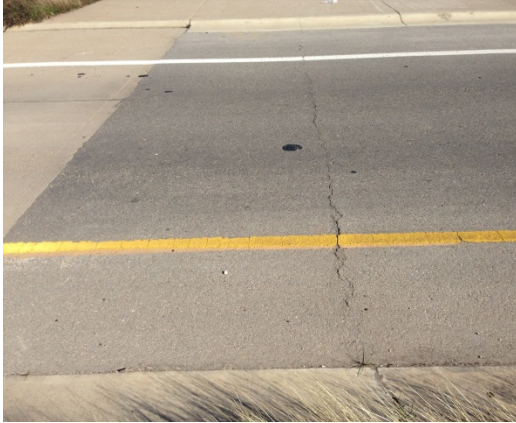
Observed Transverse Crack at Ramps

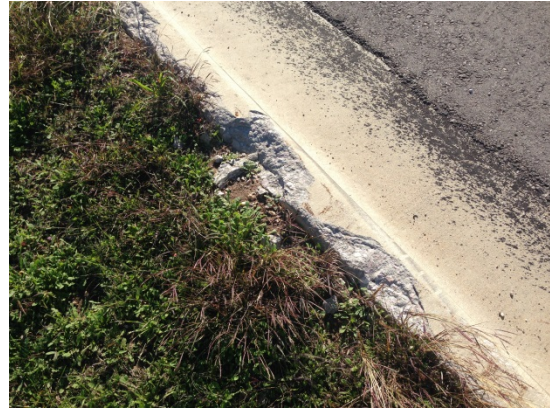
Observed Chipped Curb

The curb and gutter along 183A had no major issues, but showed signs of wear along the length of the frontage roads and mainlanes. Breaks, cracks and spalls were present in various locations. Although these issues do not affect safety and operations of the facilities, the more prominently broken curbs should be repaired.

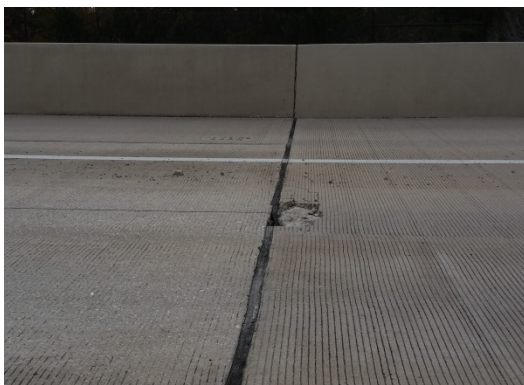
Two small potholes were identified along the concrete pavement – one located on the southbound mainlane just north of RM 1431 and the other in the southbound entrance ramp at Brushy Creek, just South of the toll gantry. These deficiencies may affect vehicles along 183A and should be repaired in a timely manner.

Observed Pothole on Brushy Creek ramp

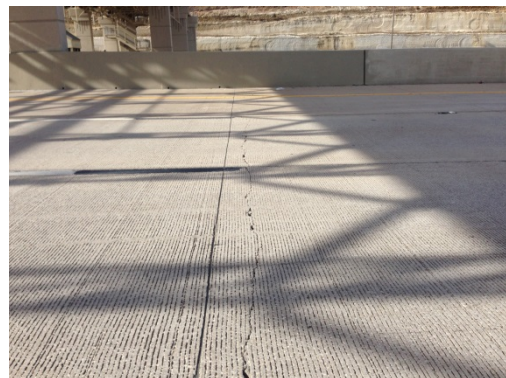
Concrete pavement along the mainlanes and frontage roads was found to be in good conditions, with some minor deficiencies present. The most prevalent deficiency was transverse cracking, which occurred at various locations along the mainlanes. While transverse cracking is common with concrete pavement, it is a relatively minor issue and does not affect safety and operations at this time. This issue does not require immediate attention, however it should continue to be monitored during future condition inspections.

Observed Transverse Cracking

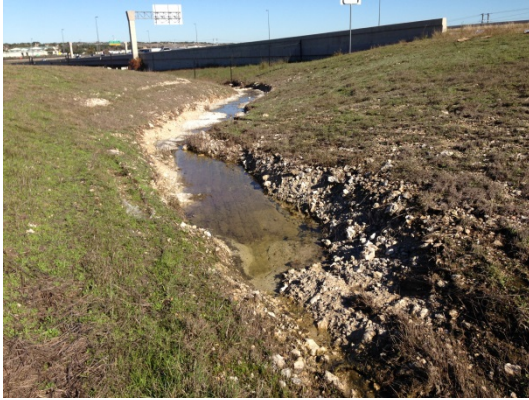
Drainage elements overall were found to be in good condition with only minor deficiencies. There was sediment buildup in some of the inlets. Minor to moderate erosion was present in several ditches and berms and at bridge drain outlets. Some driveway culverts and pond inlets were partially clogged. Some examples are shown in the pictures below.

Erosion between SBML and SBFR

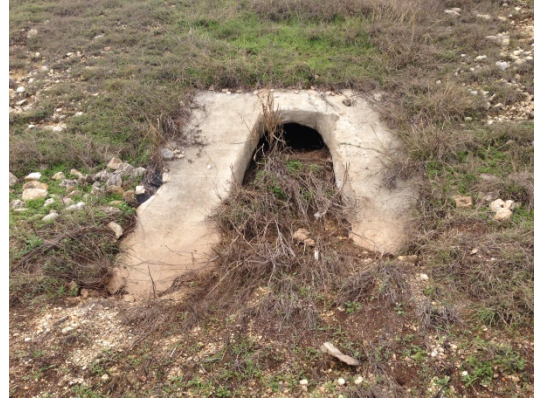
Clogged Inlet Pipe

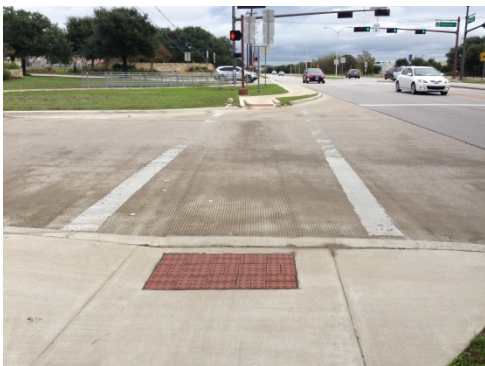
The Phase I mainlanes and ramps were observed to have significant areas of fading pavement markings, particularly at crosswalks and at ramp gores. Restriping may be needed where pavement markings are fading or missing completely. Pavement marking in Phase II was in fairly good condition, with isolated areas experiencing cracking or fading. Delineators on concrete rail and metal beam guard fence, and at gores, were missing throughout the corridor and should be replaced.

Observed Crosswalk Fading

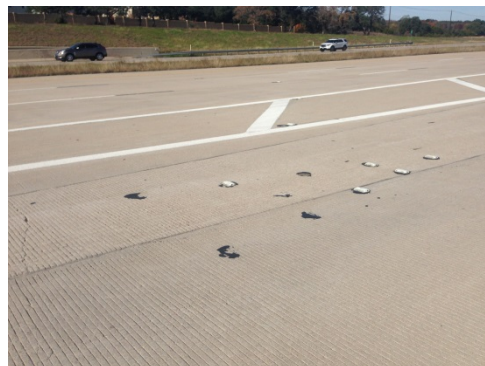
Observed Missing Buttons

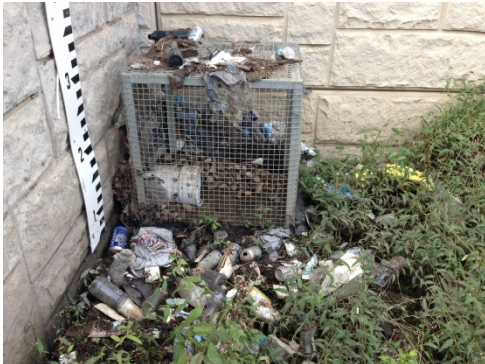
183A has numerous detention and water quality ponds along the length of the facility. These ponds serve to provide water quality treatment of the runoff from the roadway and detain the storm water where necessary. The most common issues noted were minor to severe erosion of some pond berms where water entered the pond, vegetative growth in sand filtration basins, trash buildup, and one outfall pipe not draining properly.

Observed Trash in Pond

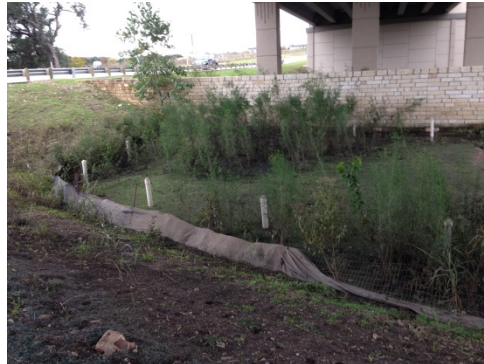
Observed Vegetation in Sand Filter Basin

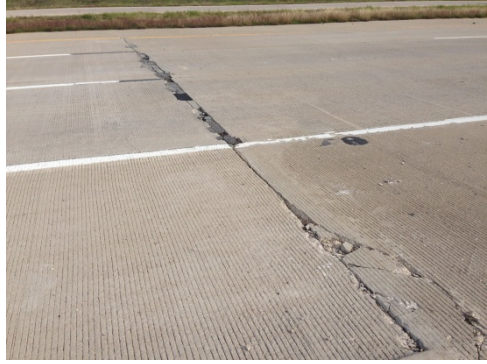
Southbound Mainlanes
North of RM 1431

- The Southbound Brushy Creek Loop, just south of the entrance ramp, is experiencing “alligator” cracking in an isolated location (see picture below). This is a sign of pavement failure and the pavement in the immediate area should be removed and replaced.
- Two potholes were identified in the concrete pavement of the southbound mainlanes and should be repaired in a timely manner. The first pothole is located just north of RM 1431 and the second can be found at the Brushy Creek Loop entrance ramp, just south of the toll gantry (see picture below).

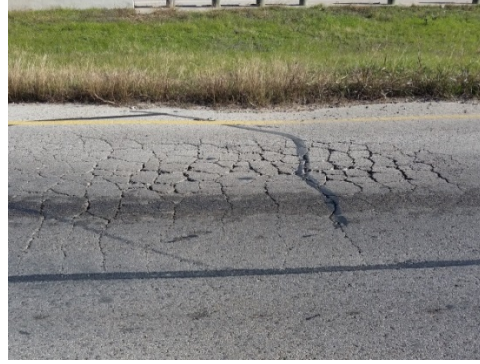
Southbound Brushy Creek Loop
Alligator Cracking

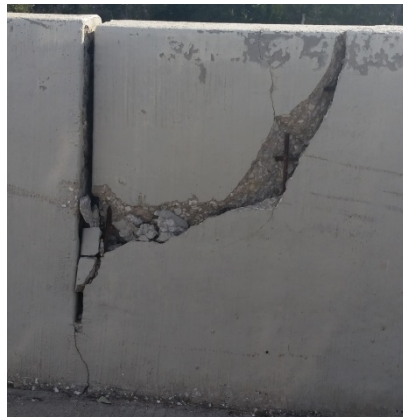
Northbound Mainlanes
North of Avery Ranch

- There is large break with exposed rebar in the Single Slope Traffic Rail (SSTR), located on the northbound mainlane, just north of Avery Ranch (see picture below). Although this damage is more detrimental to the visual appeal rather than the functionality of the SSTR, the structure should be repaired as part of facility maintenance.
- There are large vertical cracks in the SSTR at all four corners of the Northbound Entrance Ramp Bridge, south of Avery Ranch (see picture below).

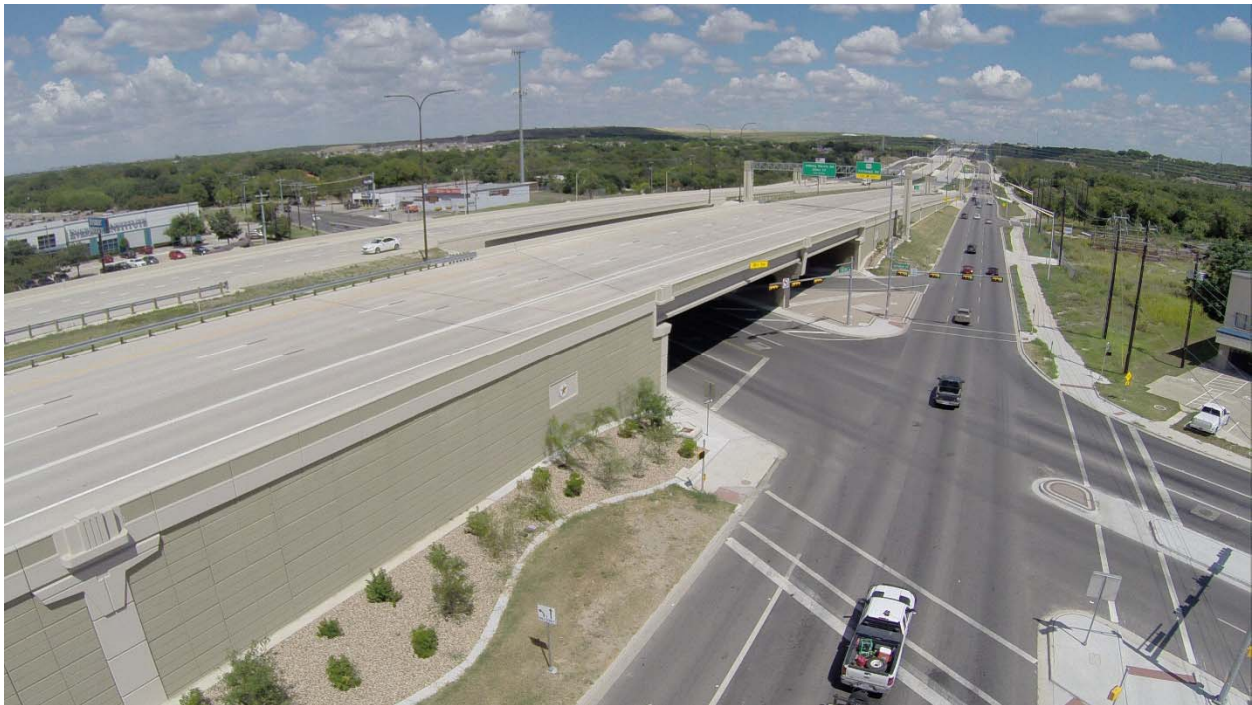
Retaining Wall S1-05 at the Southwest Corner of the Springdale Rd Intersection

Based on visual observations, both new and existing retaining walls on the Manor Expressway project are in adequate or better condition with minor cosmetic deficiencies.

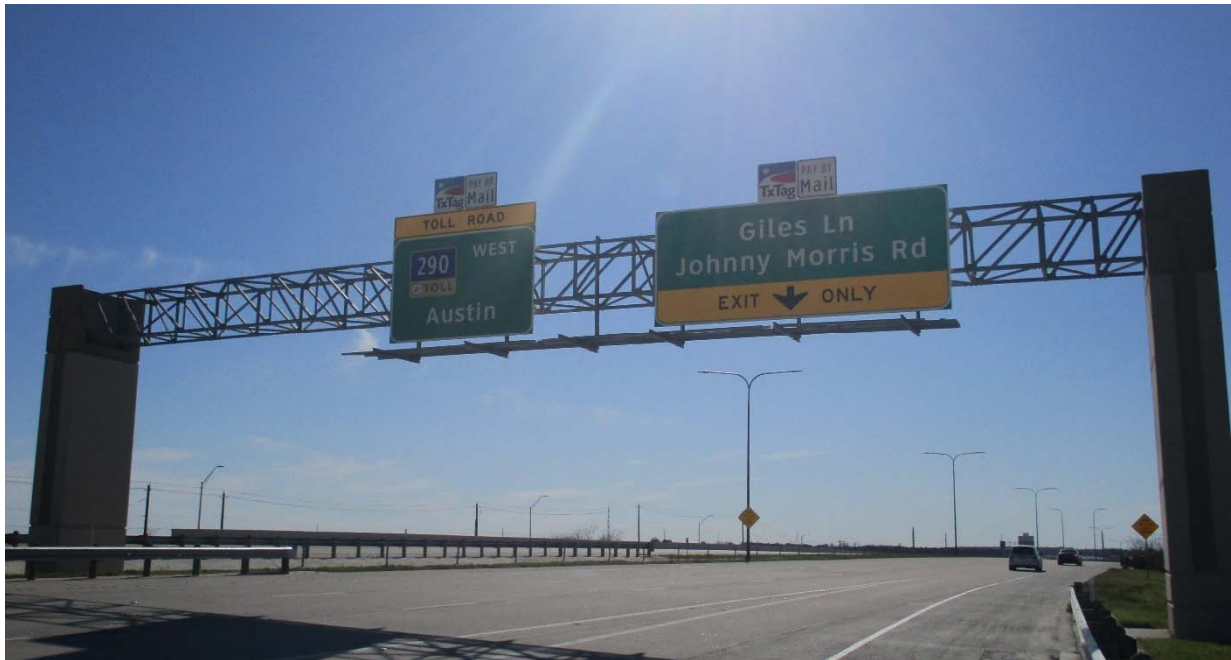
Overhead sign structure westbound approaching Johnny Morris Rd

The inspection did not reveal any unsatisfactory deficiencies in the condition and operation of the toll gantries and sign structures. Deficiencies requiring maintenance include members of a column support beginning to reveal rust stains from the presence of an iron ore aggregate which can occur naturally in the concrete coarse aggregate known as marcasite. These rust stains are limited to an aesthetic concern and are easily repaired by removing the particular piece of aggregate, patching the hole and repainting.

The inspection did not reveal any unsatisfactory deficiencies in the condition and operation of the toll gantries and sign structures. The rust stains cause by the presence of marcasite in the concrete large aggregate are limited to an aesthetic concern. The repair is to remove the particular piece of aggregate, patch the hole and repaint.
