CENTRAL TEXAS REGIONAL
MOBILITY AUTHORITY

ANNUAL REPORT OF CONDITIONS EXPRESS 1 TOLL

March 8, 2021

Subject: **2021 Annual Report of Conditions – Express 1 Toll (Mopac Express)**

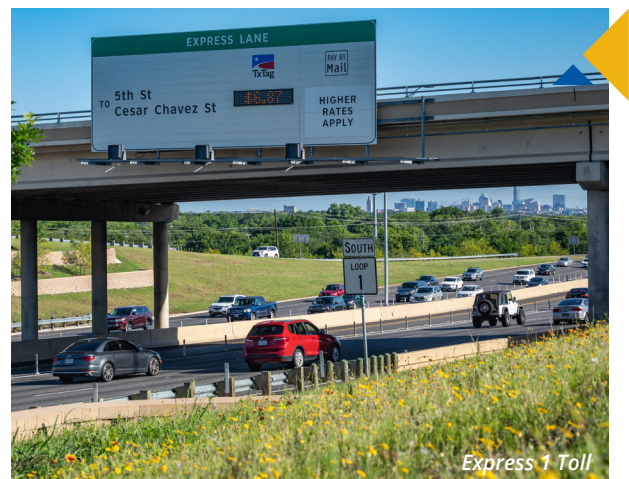
A large portion of the bollards separating the managed lanes from the general-purpose lanes were found to be non-reflective. Full replacement of these assets is recommended as part of the PBMC scope in FY 2022.
