CENTRAL TEXAS REGIONAL **MOBILITY AUTHORITY**

Geological Assessment

Barton Skyway Ramp Relief, Austin (Travis County) Texas

June 2021

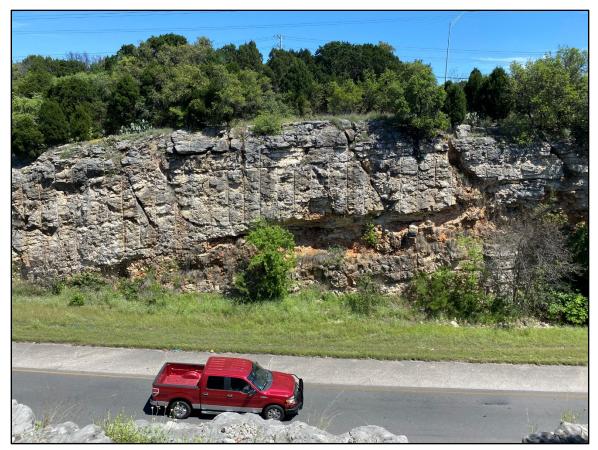
Project Photo 1. Fault lines of the Balcones Fault Zone are expressed in sets that reflect adjustments within damage zones. There is an angular contrast between vertical drill scars and slashed fracture lines. This image is facing northeast along the ramp from southbound MoPac to southbound SL 360 (towards South Lamar Boulevard). On the left side of the photo, strata are dipping northwest towards the Loop 1 Syncline (Detail in Project Photo 2). This fault crosses the Project Area from 550 feet south of Tuscan Terrace to 820 feet north of Barton Creek at a 45° trend and has a displacement of 40 feet.

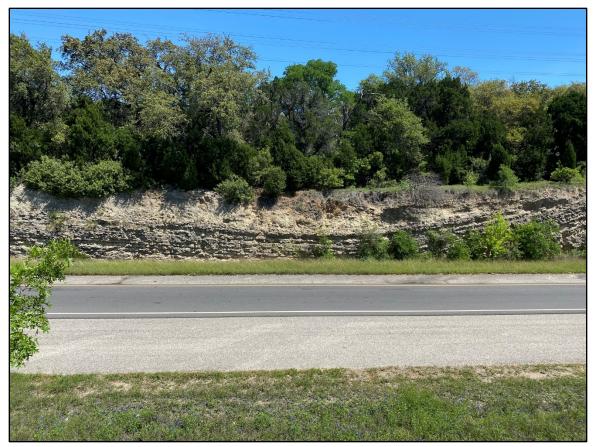
Project Photo 2. The Loop 1 Syncline is an expression of downward folded bedding in the GeorgetownFormation. Folded beds can be seen along the ramp from southbound Mopac to southbound State Loop360. The hinge line of the sinkhole is shown as a purple line on the geologic map (COA 2014).

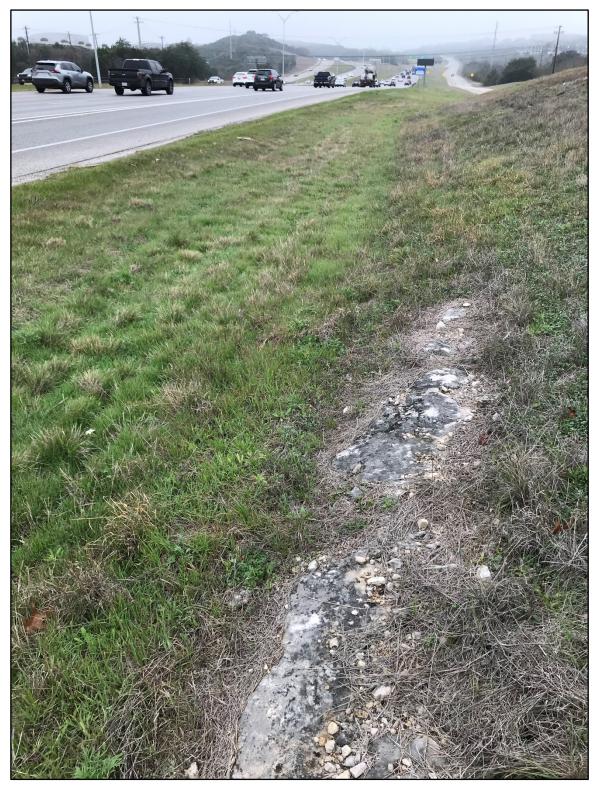
Project Photo 3. Exposure of the Georgetown Formation (gray bedrock in foreground) between the southbound mainlanes and the frontage road.

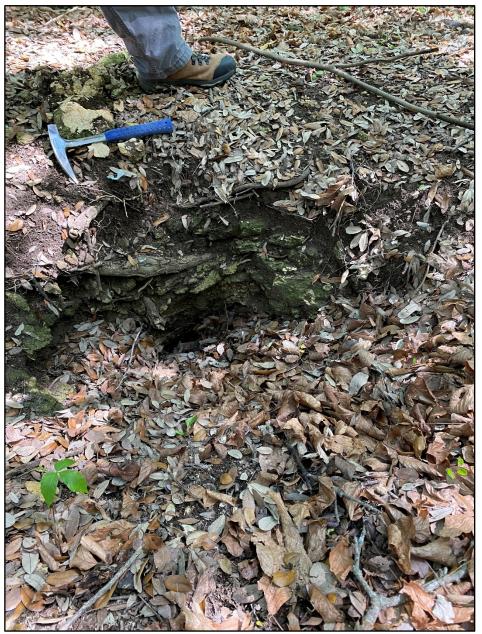
MPS-6 NON-KARST CLOSED DEPRESSION. This feature is a previously excavated closed depressed in the Del Rio Clay. The depression is 9 feet by 7 feet by 2 feet deep. The depression was previously identified as "MP-011" in the draft MoPac South report cited in the Previous Geologic Assessments section of this report. Limestone cobbles observed within the depression likely originated upslope (i.e., Buda Limestone fragments were transported downslope). The feature is not sensitive and was not re-excavated.

Feature Photo MPS-6 Non-karst Closed Depression. The depression is formed in the Del Rio Clay.

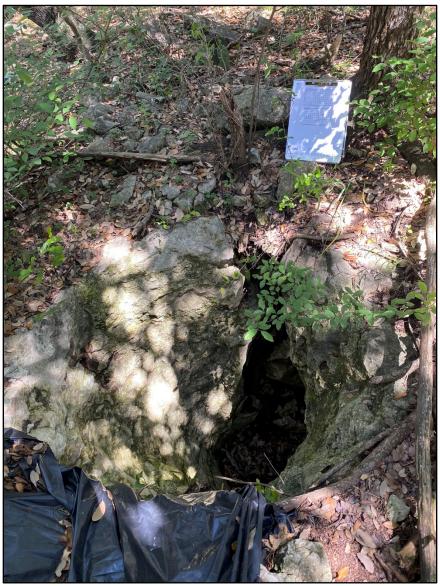
MPS-7 SOLUTION CAVITY. This previously excavated karst feature formed in the Leached and Collapsed Member of the Person Formation. The cavity opening is 46 by 43 inches across and 7 feet deep. Rock dissolution was focused along a 45° fracture trend. The feature was previously identified as "MP-012" in the draft MoPac South report cited in the Previous Geologic Assessments section of this report. The feature was not excavated as rock floor was reached during previous excavation work. The feature is considered sensitive to recharge.

Feature Photo MPS-7 Solution Cavity. Remnant plastic tarp and plywood covers from a previous investigation are present near the opening.

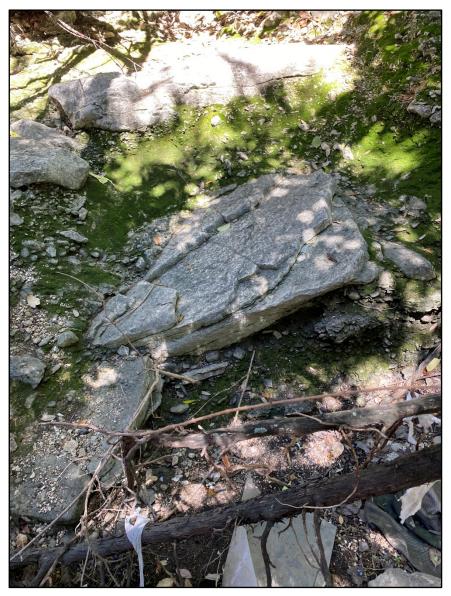
MPS-18 OTHER NATURAL BEDROCK FEATURE. This feature is located below a stormwater outfall outside the northbound frontage road and was described in a previous geologic assessment as a solution enlarged fracture. It is now being classified as an other natural bedrock feature because no fractured rock was observed. Debris from a recent vehicle crash may have obscured fractured rock. The feature was previously identified as "MBB-11" in the draft MoPac South report cited in the Previous Geologic Assessments section of this report.

Feature Photo MPS-18 Other natural bedrock features. The image shows rock slabs that are likely not in place. The fractured rock reported at this location was not observed.

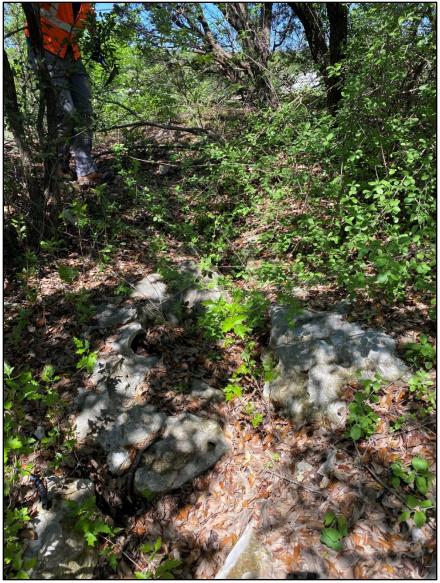
MPS-19 SOLUTION ENLARGED FRACTURE. The fracture is 27 feet long, extending to the west edge of the pinnacle between the southbound MoPac frontage road and the taper of the ramp from southbound MoPac to southbound State Loop 360. The width ranges between 12 and 18 inches. The depth is at least 15 inches but could extend further as the leaves and soil filling the fracture are loose. The feature was previously identified as "MBB-12" in the draft MoPac South report cited in the Previous Geologic Assessments section of this report. The feature is rated as sensitive.

Feature Photo MPS-19 Solution Enlarged Fracture (Photo 1 of 2). The 27-foot long fracture is situated on top of a pinnacle. The fracture is partly covered with leaves. It runs between the two limestone slabs in the lower part of the image, to the right of the person standing for scale.

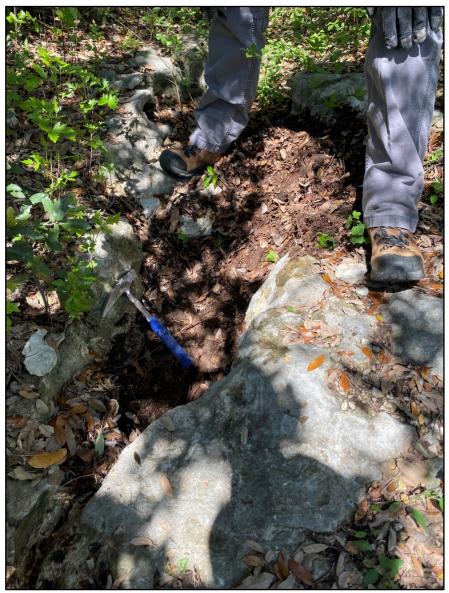
Feature Photo MPS-19 Solution Enlarged Fracture (Photo 2 of 2). The hammer is for scale at the widest part of the fracture (18 inches). The depth is at least 15 inches but could extend further as the leaves and soil filling the fracture are loose.

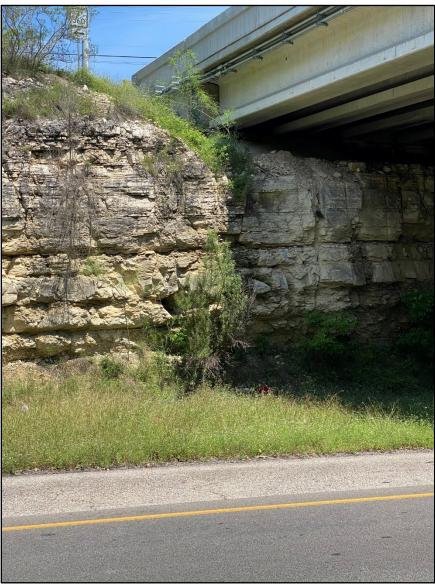
MPS-20 SOLUTION CAVITY. This feature consists of a solution cavity along a cliff face. The one-foot diameter solution cavity is associated with a fracture that trends 25°. The cavity extends approximately 3 feet into the cliff face. It is about 5 feet above the flow line at the base of the cliff making the recharge potential low. The feature was previously identified as "MBB-14" (a solution enlarged fracture containing a cavity) in the draft MoPac South report cited in the Previous Geologic Assessments section of this report. The feature is non-sensitive and was not excavated.

Feature Photo MPS-20 Solution Enlarged Fracture (Photo 1 of 2). This feature consists of a fracture with a solution cavity along a cliff face.

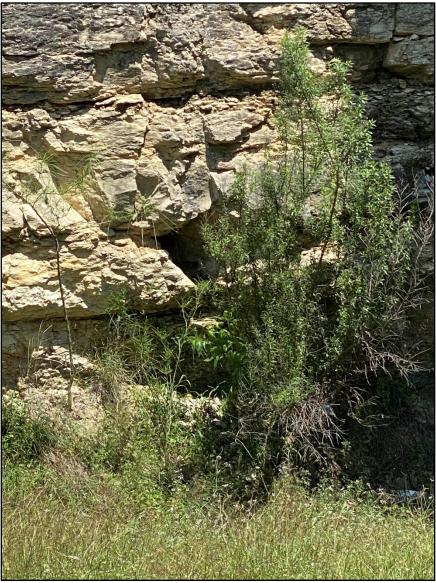
Feature Photo MPS-20 Solution Enlarged Fracture (Photo 2 of 2). The solution cavity associated with this fracture (center of image) is about 5 feet above the flow line at the base of the cliff.

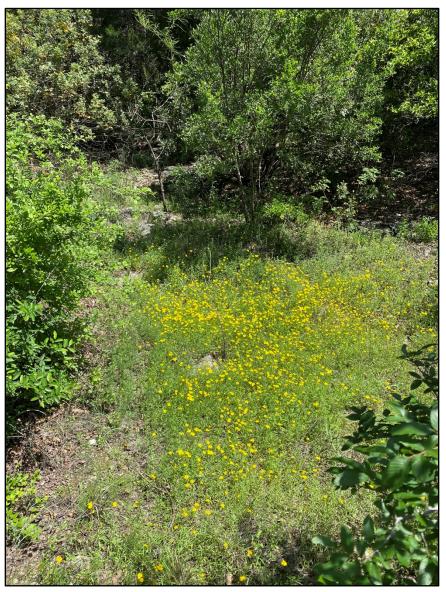
MPS-21 NON-KARST CLOSED DEPRESSION. This feature consists of a closed depression located north of State Loop 360 adjacent to a utility pole above the bicycle and pedestrian bridge abutment. The depression is 22 feet by 16 feet and 2 feet deep. The bottom has an intact soil floor. Isolated bedrock slabs are on the margins indicate that the depression is the result of grading. The feature was previously identified as "MBB-20" in the draft MoPac South report cited in the Previous Geologic Assessments section of this report. The feature is non-sensitive and was not excavated.

Feature Photo MPS-21 Closed Depression. Facing north at the shallow depression.

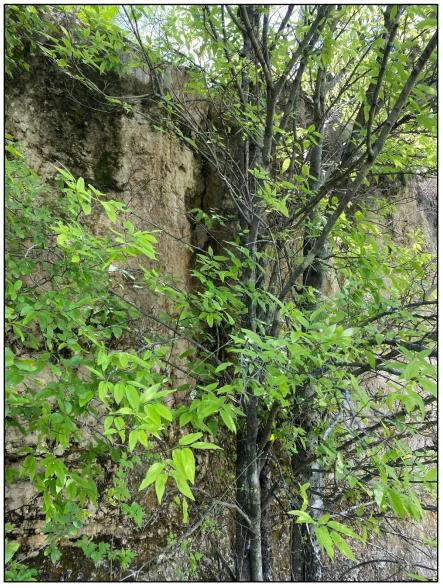
MPS-22 SOLUTION ENLARGED FRACTURE. This is a prominent fracture (southwest of MPS-23) exposed in a 100-foot wide cliff face along the west side of a pinnacle. The feature was previously identified as "MBB-21" in the draft MoPac South report cited in the Previous Geologic Assessments section of this report. The previous feature coordinates placed it within the transmission tower pad. Based on the description and photo comparison, the feature is located on the west pinnacle face. The feature is non-sensitive and was not excavated.

Feature Photo MPS-22 Solution enlarged fracture. The fracture is obscured by trees.

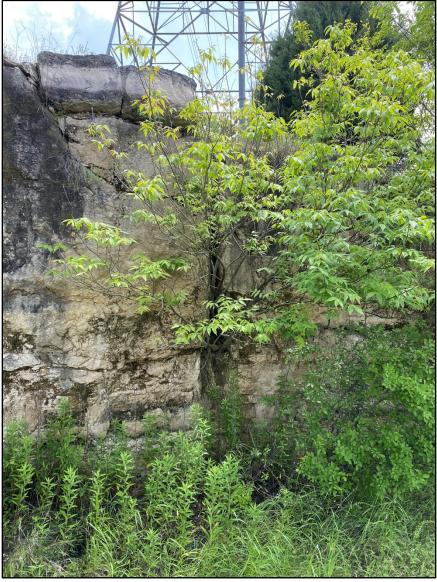
MPS-23 SOLUTION ENLARGED FRACTURE. This feature is a prominent vertical fracture (one of eight including MPS-22) exposed in the center a 100-foot wide cliff face along the west side of a pinnacle. A tree is growing in the soil infill.

Feature Photo MPS-23 Solution Enlarged Fracture (Photo 1 of 2). Facing east at the cliff face. Southbound State Loop 360 is to the left.

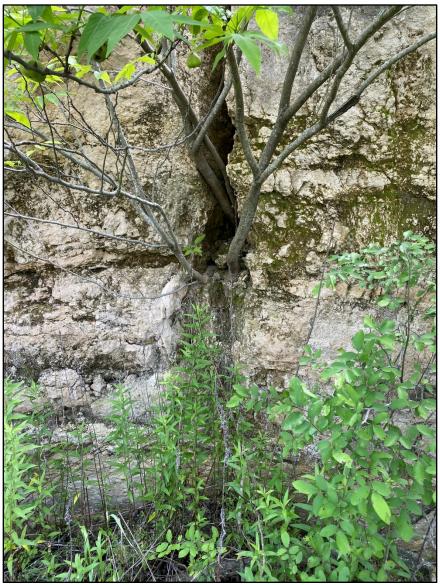
Feature Photo MPS-23 Solution Enlarged Fracture (Photo 2 of 2). The fracture was enlarged from chemical dissolution and physical (tree root growth) processes.

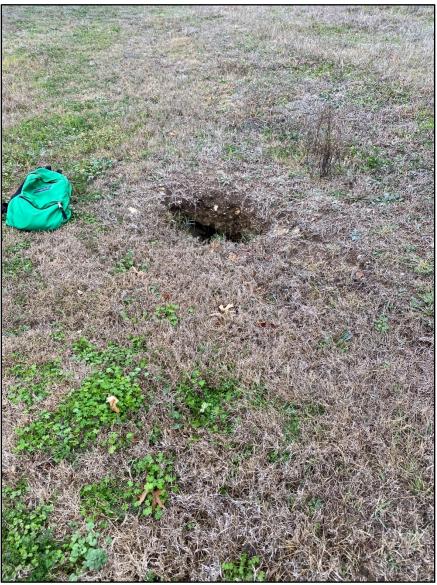
MPS-27 NON-KARST CLOSED DEPRESSION. This feature consists of a collapse associated with a utility line. The depression is 24 inches by 12 inches. There is a small opening that extended 24 inches deep. No in place bedrock was observed.

Feature Photo MPS-27 Non-karst Closed Depression.

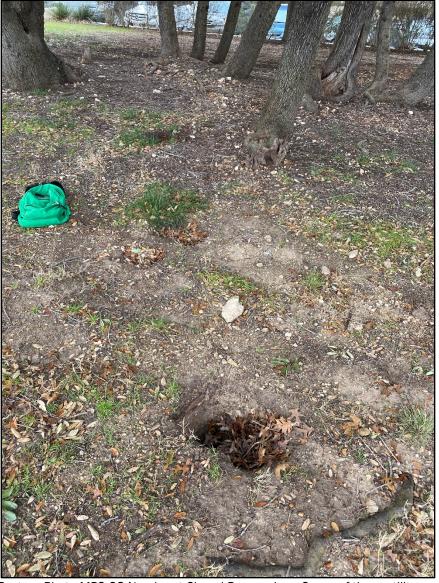
MPS-28 NON-KARST CLOSED DEPRESSION. This feature consists of three utility potholes likely associated with fiber optic installation outside of the northbound frontage road between Spyglass Drive and RM 2244. The sides of the hole had a smooth edge consistent with a hole dug with a shovel and no in place bedrock was observed.

Feature Photo MPS-28 Non-karst Closed Depression. Group of three utility potholes each about 18 inches in diameter. No bedrock exposures were present.

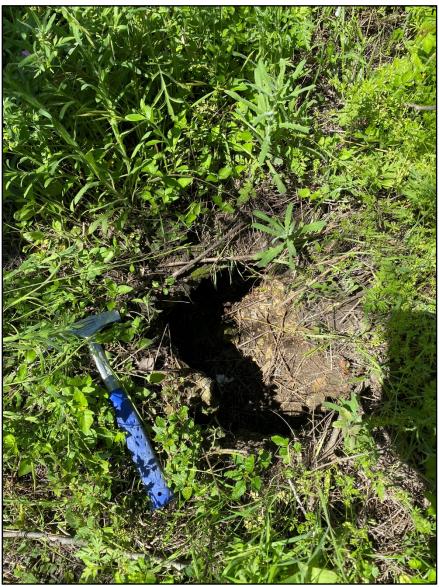
MPS-30 NON-KARST CLOSED DEPRESSION. This feature consists of a manmade excavation that is 16 inches in diameter and one foot deep. There was no in place bedrock observed. The hole is aligned with an existing electric transmission line.

Feature Photo MPS-30 Non-karst Closed Depression. This closed depression is likely related to the existing utility line. No bedrock exposures are present.

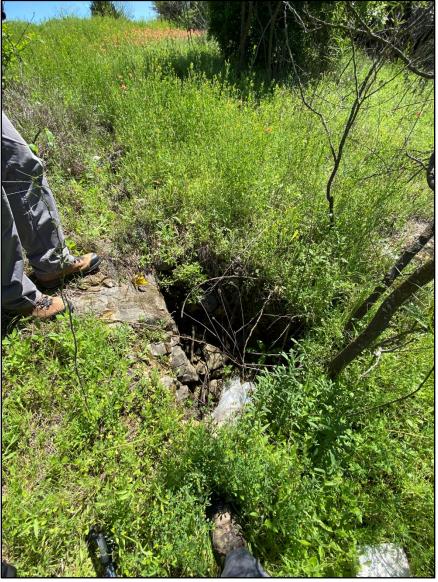
MPS-31 NON-KARST CLOSED DEPRESSION. This feature consists of a manmade excavation that is 3.5 feet by 2.5 feet and one foot deep. There was no in place bedrock observed. The hole is aligned with an existing electric transmission line.

Feature Photo MPS-31 Non-karst Closed Depression. This closed depression is likely related to the existing utility line. No bedrock exposures are present within the depression.

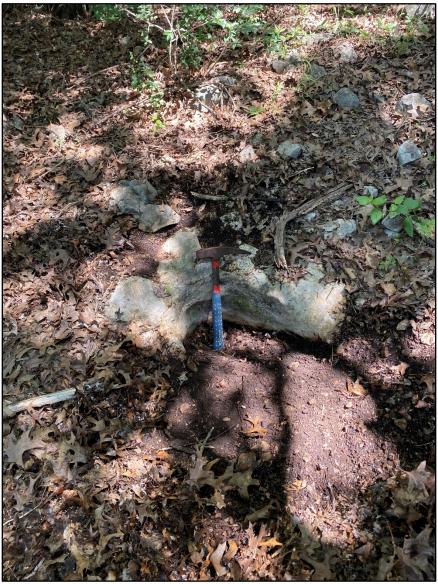
MPS-32 SOLUTION CAVITY. This feature consists of a solution cavity rimmed with limestone on three sides, measuring 1.5 feet by 0.8 feet. The feature was filled with dark loose organic-rich soil. The depth of probing reached 1.3 feet. The feature was excavated 8 to 10 inches which revealed abundant tree roots within the loose soil infill indicating that the soil has a long residence time.

Feature Photo MPS-32 Solution Cavity.

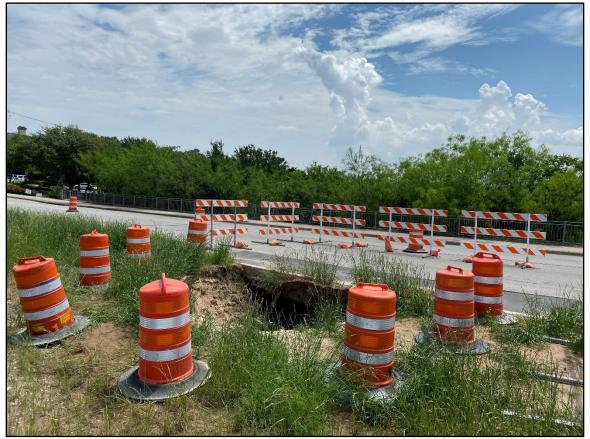
MPS-33 NON-KARST CLOSED DEPRESSION. The depression formed suddenly (first observed on 7 April 2020), and the ground surface surrounding it has since been restored. The depression that formed was a non-karst, human induced sinkhole within fill material situated over a stormwater culvert. The depression was adjacent to the northbound frontage road approximately160 feet north of Bartons Bluff. It formed suddenly following a rain event during the first four days of April 2020. The visible depression was 17 feet in diameter but the feature extended under the pavement and was approximately 32 feet in diameter in total and at least 15 feet deep. A 40-foot long pavement patch along the left lane of the northbound frontage road indicates that the land surface had previously changed and, according to the maintenance crew responding to the hazard, a repair was made in the spring of 2019. The top of a 96-inch diameter culvert structure (a corrugated galvanized metal pipe) is approximately 35 feet below the ground surface. The feature is situated within a former topographic low at a sharp bend in an unnamed tributary to Barton Creek.

Feature Photo MPS-33 Non-karst Closed Depression (Photo 1 of 3). Traffic barriers were in place surrounding the hazard. Photo taken on April 8, 2020.

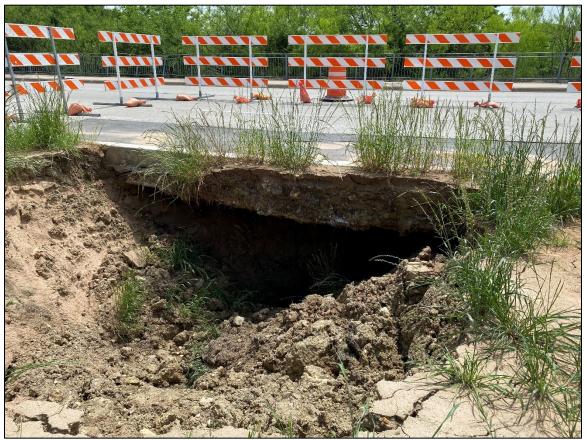
Feature Photo MPS-33 Non-karst Closed Depression (Photo 2 of 3). The depression was not excavated or probed due to the risk of further collapse. Photo taken on April 8, 2020.

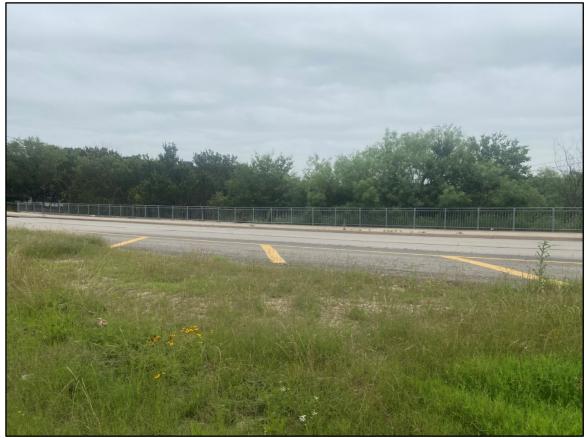
Feature Photo MPS-33 Non-karst Closed Depression (Photo 3 of 3). The land surface surrounding the depression was subsequently restored.
