Draft Waters of the U.S. Delineation Report

Barton Skyway Ramp Relief

MoPac Expressway from
Barton Skyway to Loop 360
(CSJ 3136-01-193)

Texas Department of Transportation, Austin District

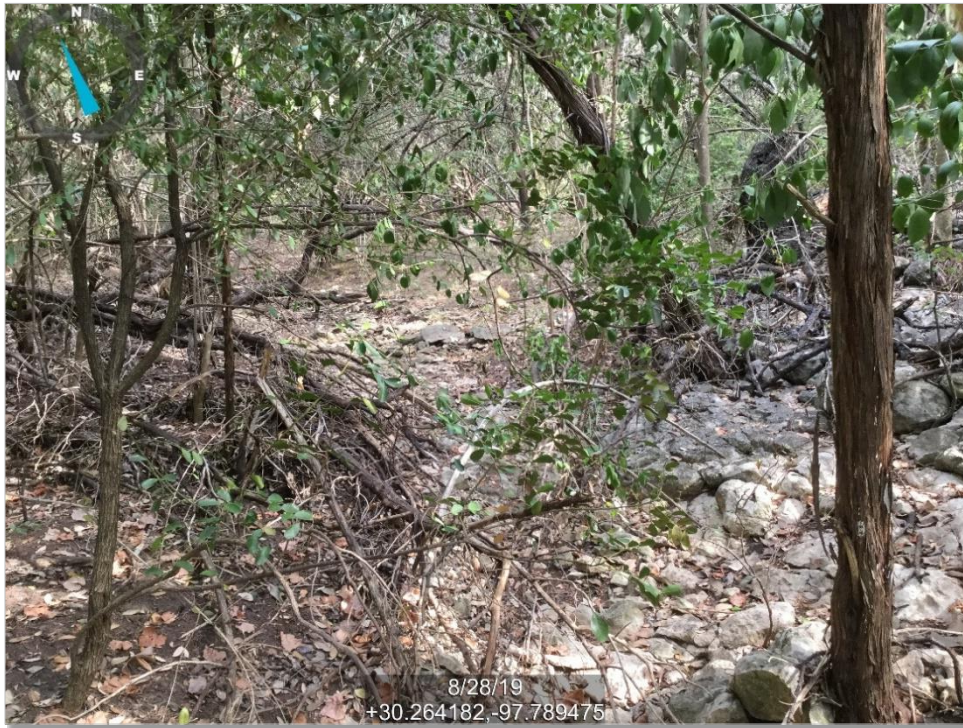
Photo 1: Typical upstream view of CRK 01, an unnamed potentially jurisdictional ephemeral stream.

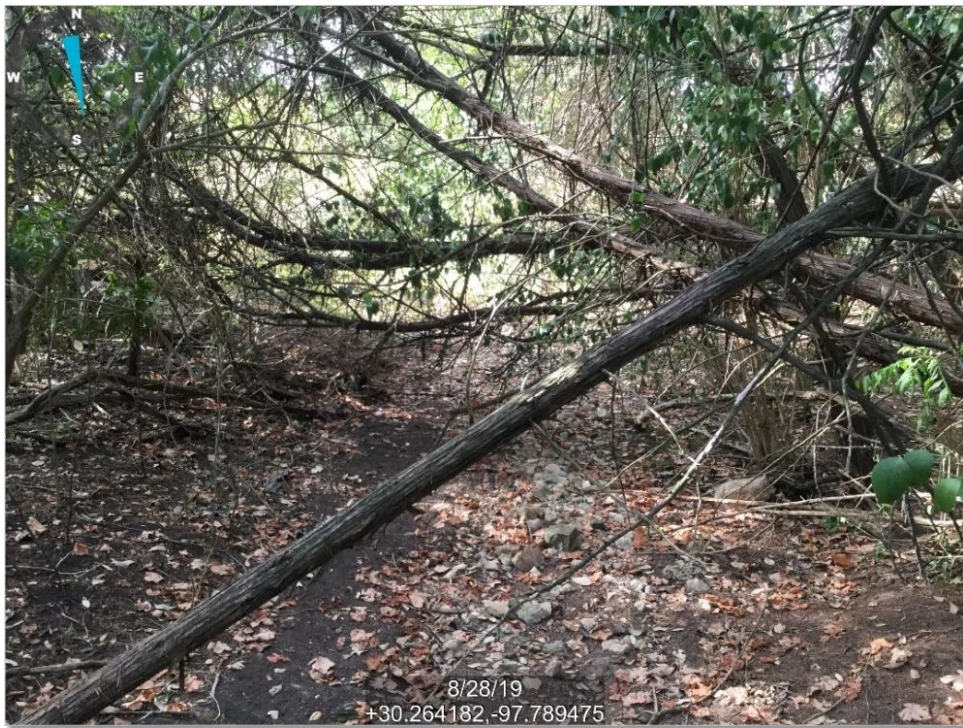
Photo 2: Typical downstream view of CRK 01, an unnamed potentially jurisdictional ephemeral stream.

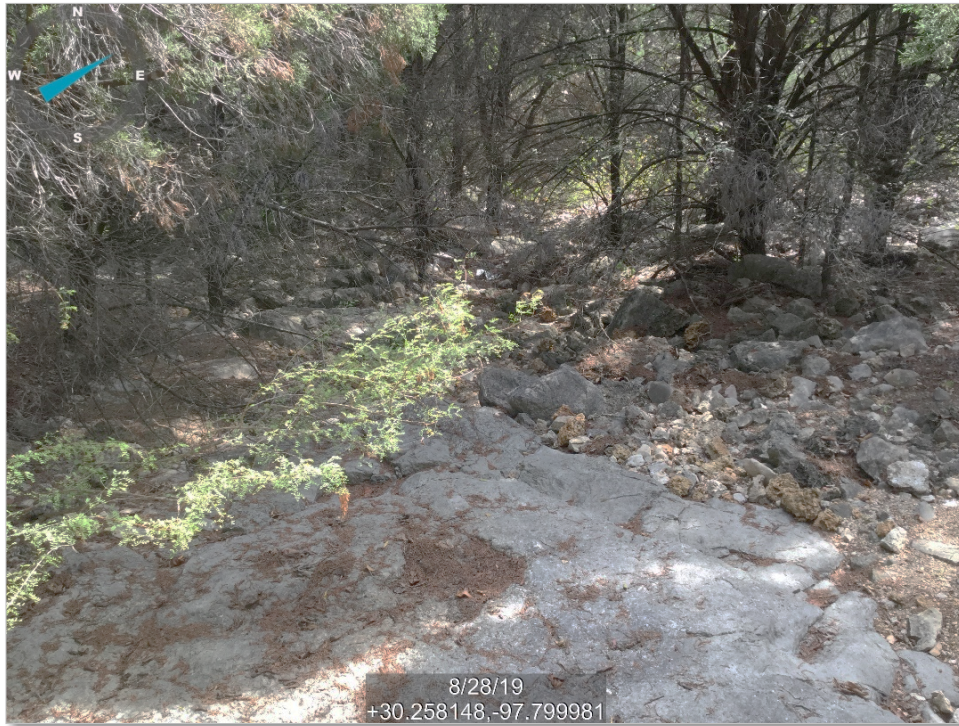
Photo 3: Typical upstream view of CRK 02 (Skunk Hollow Creek), a potentially jurisdictional ephemeral stream.

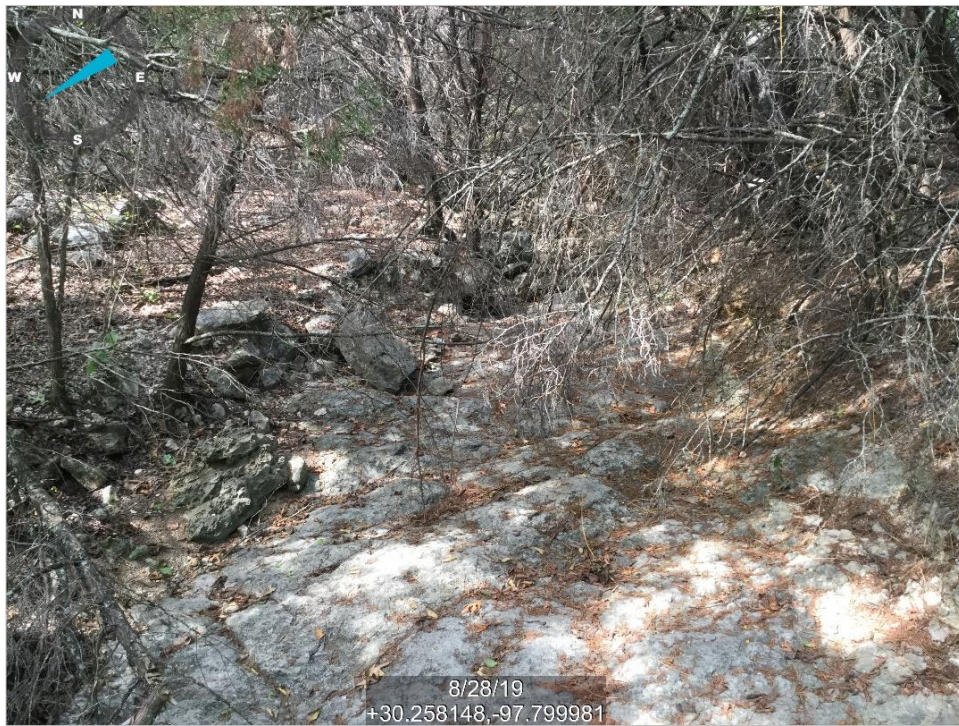
Photo 4: Typical downstream view of CRK 02 (Skunk Hollow Creek), a potentially jurisdictional ephemeral stream.

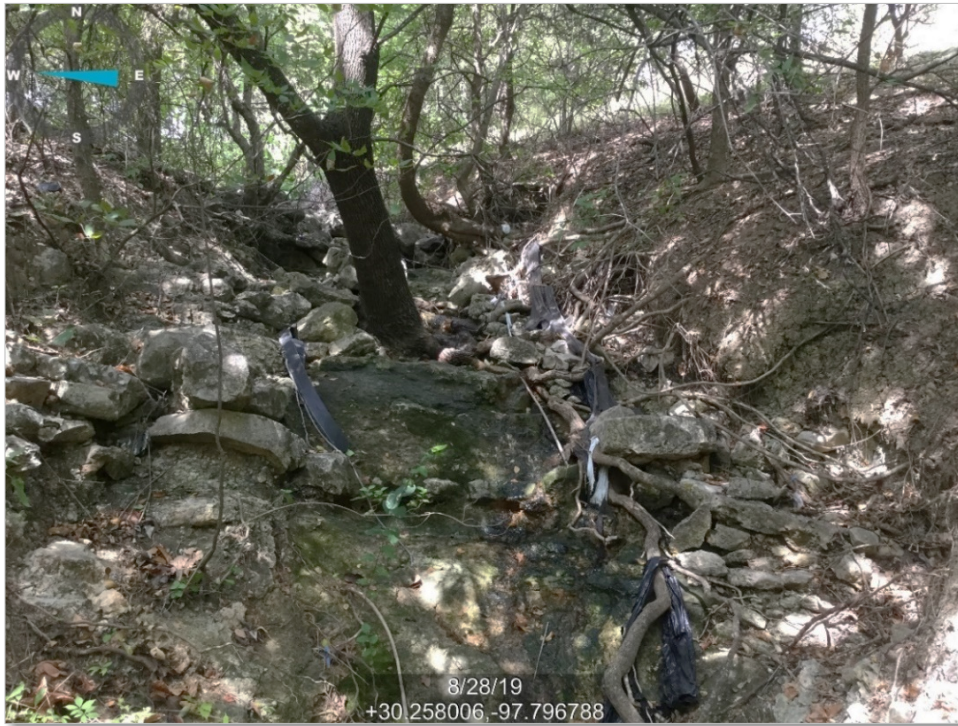
Photo 5: Typical upstream view of CRK 03, a potentially jurisdictional unnamed ephemeral tributary to Skunk Hollow Creek.

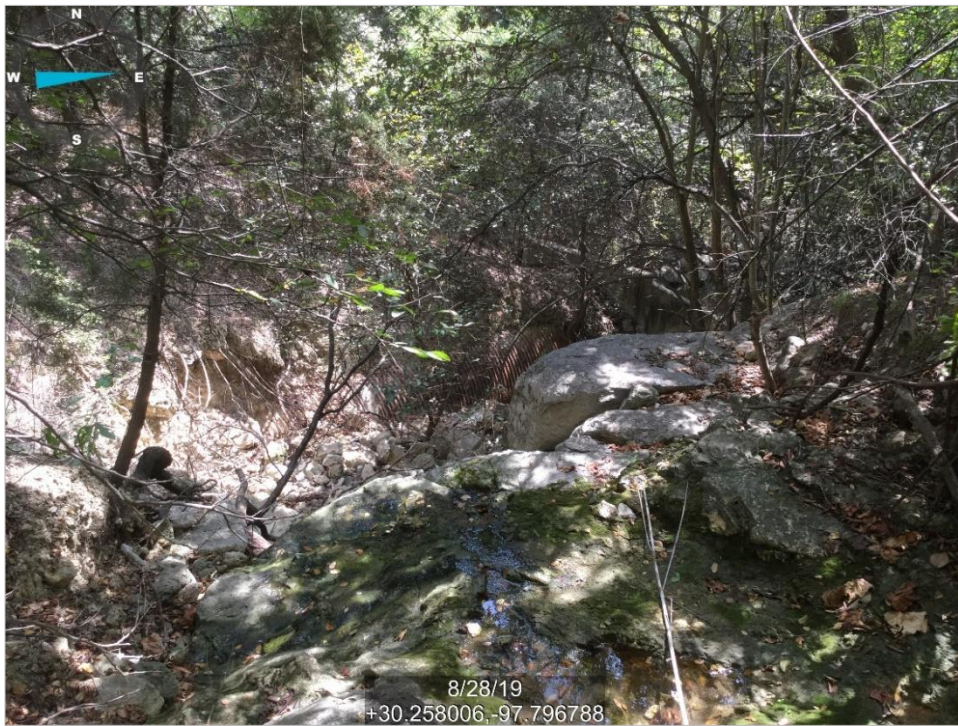
Photo 6: Typical downstream view of CRK 03, a potentially jurisdictional unnamed ephemeral tributary to Skunk Hollow Creek.

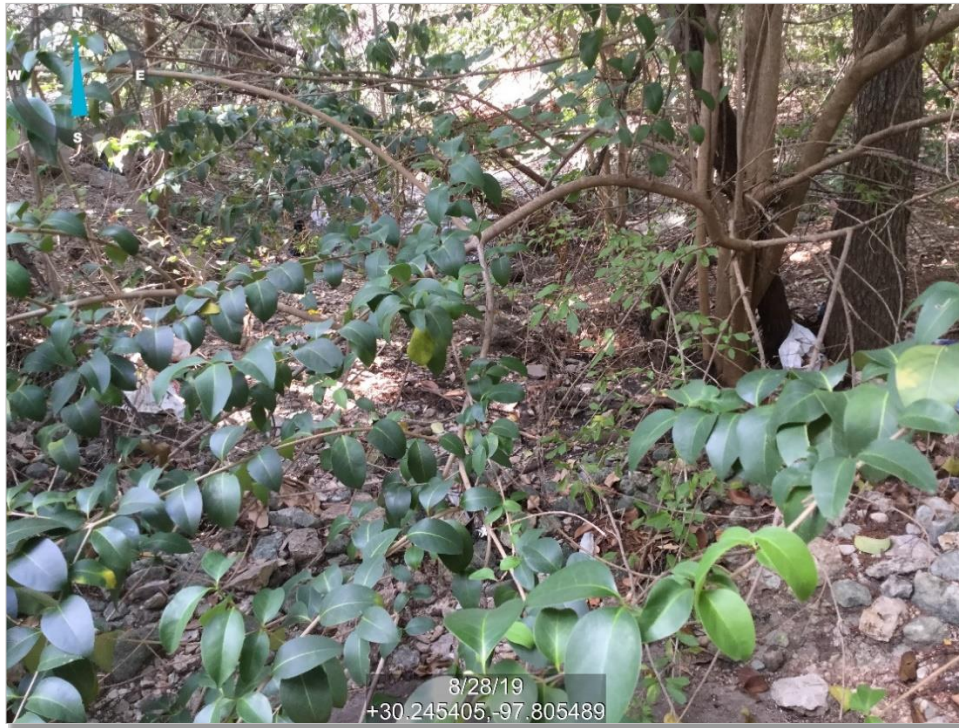
Photo 7: Typical upstream view of CRK 04, a potentially jurisdictional unnamed ephemeral stream.

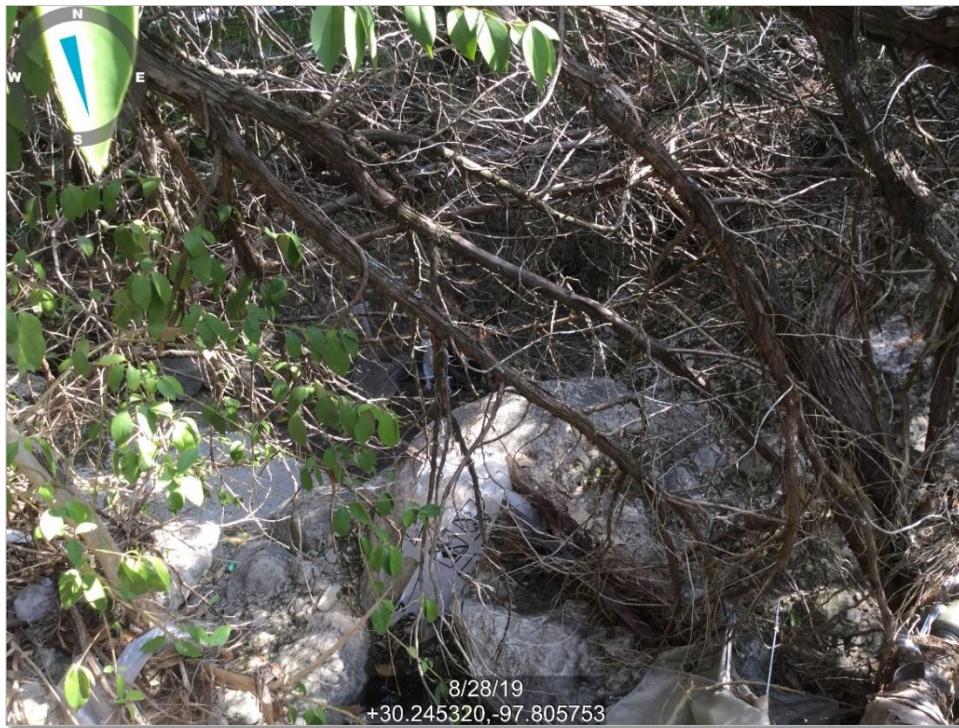
Photo 8: Typical downstream view of CRK 04, a potentially jurisdictional unnamed ephemeral stream.
