CENTRAL TEXAS REGIONAL
MOBILITY AUTHORITY

2019 ANNUAL REPORT OF CONDITIONS

Subject: 2019 Annual Report of Conditions – 183A Turnpike, 290E Project, SH 71 Express and 183 South Interim Milestone Roadways

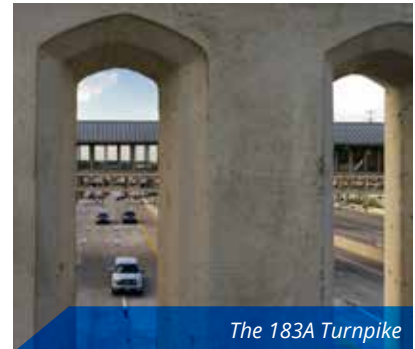
Although minor issues were noted, the inspection conducted in November 2018 did not identify any major deficiencies in the asphalt pavement that would affect the safety and operations of 183A Turnpike. An overlay of 183A Turnpike frontage road pavement is tentatively scheduled for 2021. This overlay will serve as a preventative maintenance treatment to rejuvenate the pavement and provide a new driving surface for motorists. This preventative maintenance supports a pavement management plan that is focused on maximizing the useful life.

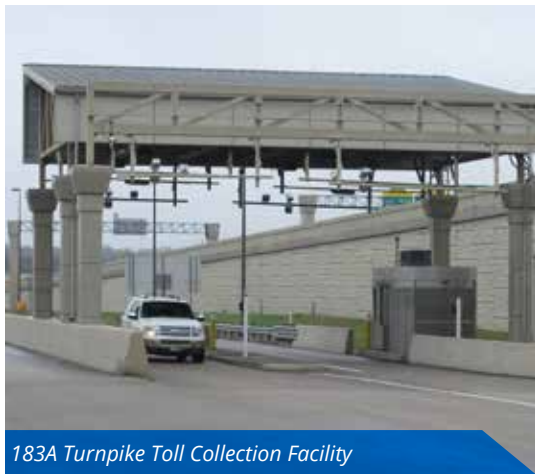
The inspection did not reveal any unsatisfactory deficiencies in the condition and operation of the toll gantries and sign structures. The most common deficiencies noted were galvanization failure and minor rusting.

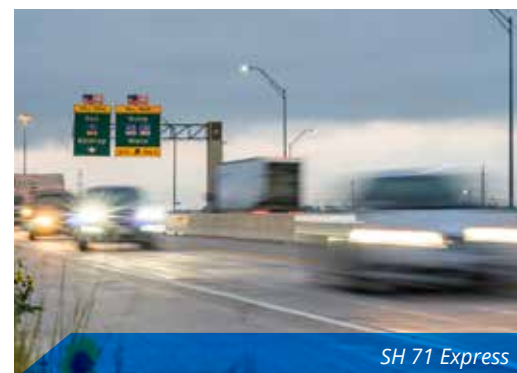
The newly constructed concrete pavement sections along the corridor are in excellent condition with no deficiencies, with the exception of the ride quality at one location across lanes in both directions where the pavement transitions from concrete to existing flexible pavement. These values exceed the warranty threshold referenced in Table 7, section 1.2 Pavement, Ride Quality. This issue does not require immediate attention; however, it should continue to be monitored during the warranty period. CTRMA has been in discussions with TxDOT regarding this issue.
