**Re: 2014 Annual Report of Conditions – 183A Turnpike / Manor Expressway**

**2014 Annual Report of Conditions**  
**183A Turnpike – HNTB**  
**Manor Expressway - Atkins**

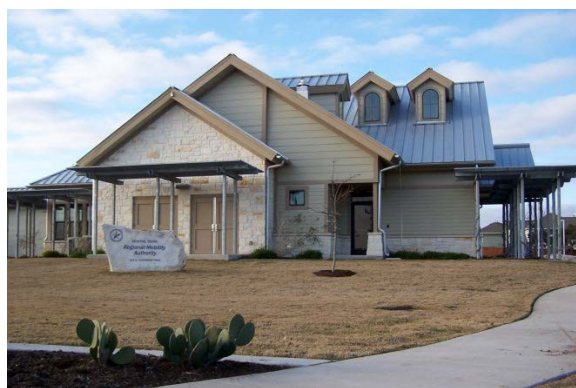
183A Turnpike Field Operations Building

**Field Operations Building** – Overall, the mainlane plaza facilities at Park Street generally are in very good condition. The interior of the Field Operations Building (FOB) was being renovated at the time of inspection. The most significant deficiencies noted were expired inspection certificates for fire extinguishers and elevator, exposed wiring near the air conditioner condenser unit, and clearance around the fire hydrant not meeting the minimum required by the Cedar Park Fire Marshal. The Mobility Authority is coordinating with the local fire marshal to determine the necessary steps to make the fire hydrant compliant.

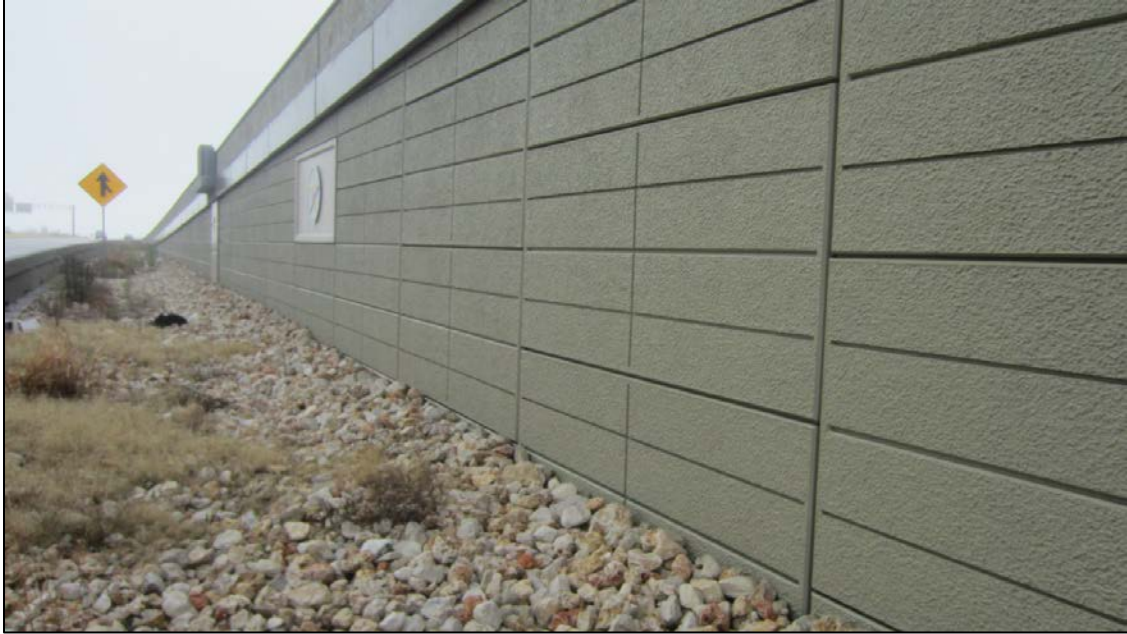
Retaining wall along the westbound Manor Expressway to southbound US 183 departure

Based on visual observations, both new and existing retaining walls on the Manor Expressway Phase I project are in very good condition. There were no significant deficiencies noted during the inspection. However, minor settlement at the abutment face and spalling at abutment coping was found at certain locations along the existing TxDOT retaining wall on the departure end of the westbound Manor Expressway to northbound US 183 direct connector. A list of deficiencies is being provided to the Mobility Authority to forward to the PBMC maintenance contractor to be addressed.

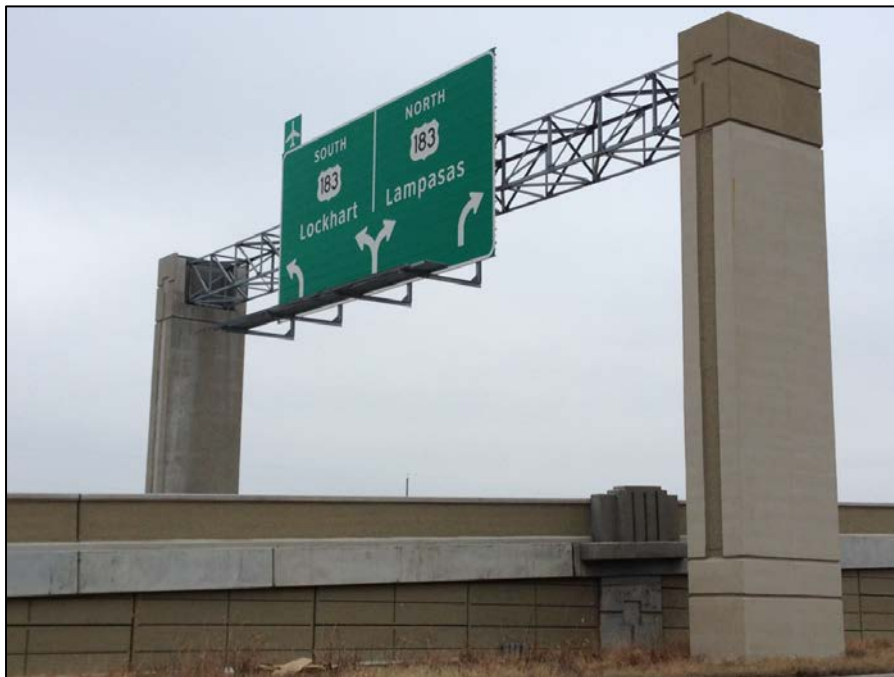
Overhead sign structure approaching westbound direct connectors

The inspection did not reveal any major deficiencies in the condition and operation of the toll gantries and sign structures. Minor deficiencies, including members of a column support have begun to rust in areas where the galvanized finish has been rubbed.
