CENTRAL TEXAS REGIONAL  
MOBILITY AUTHORITY

# 2021 ANNUAL REPORT OF CONDITIONS

Subject: **2021 Annual Report of Conditions – 183A Turnpike, 290E, SH 71 Express, SH 45 Southwest, 183 South, 183 North Mobility Project**

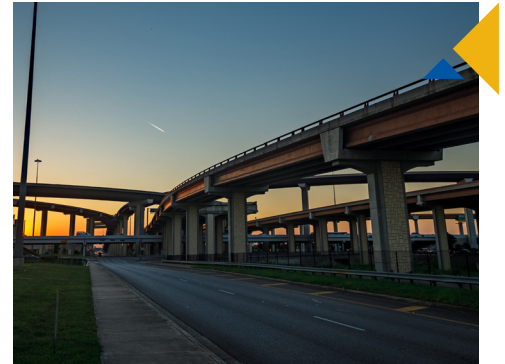
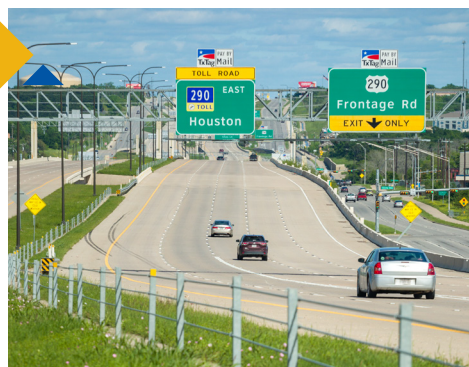
### 1.3.1. 183A TURNPIKE

The Mobility Authority constructed, operates and maintains the 183A Turnpike, a tolled facility stretching 10.4 miles from RM 620 to CR 276 in Williamson County. The corridor is a critical link in the highway network serving an area experiencing tremendous development and economic growth. The first phase of 183A Turnpike opened to traffic in March 2007, effectively reducing congestion, enhancing mobility, and providing safer travel. Phase II opened to traffic in April 2012 and included a 4.7-mile extension of the shared use path adjacent to the 183A Turnpike from RM 1431 to Hero Way, resulting in a significant shift of traffic from the non-tolled frontage roads to the new tolled mainlanes. In fall 2015, the intersection of 183A Turnpike and US 183 was reconstructed to make the intersection safer, easier to navigate and to enable better access to developments along the 183A Turnpike corridor. The third phase of the 183A Turnpike has been designed and developed. Construction of the 183A Phase III Project is anticipated to begin in 2021. The new 6.6-mile roadway will extend the existing 183A corridor northward from Hero Way to 1.1 miles north of SH 29 and provide two tolled lanes in each direction, within the existing TxDOT and Mobility Authority right-of-way and within the median of the existing US 183 corridor.

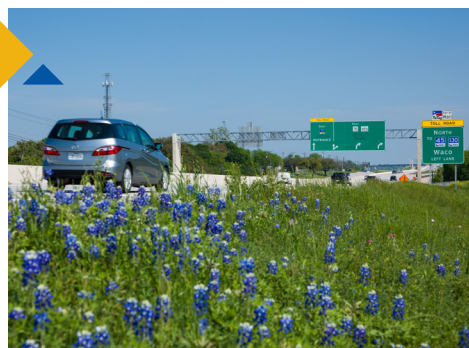
### 1.3.2. 290E

The Mobility Authority constructed, operates, and maintains the 290E, a 6.2-mile limited-access toll road along US 290 East, spanning from US 183 to just east of Parmer Lane. The corridor is a significant link to important roadways in the region including US 183, IH-35 and SH 130, and provides a critical evacuation route from the Gulf Coast region. The first phase of 290E, which consisted of four tolled direct connectors at the US 183 interchange, opened in December 2012. The second phase of the project opened to traffic in May 2014, effectively reducing congestion on US 290 East and bringing reliable travel times for tolled and non-tolled travel.

The Mobility Authority, in partnership with TxDOT, finished construction in 2021 of three new direct connector (DC) flyover bridges at the convergence of 290E and SH 130 to link the two facilities together. This gives drivers a safe, efficient, free-flowing direct connection between the two toll roads. The new flyovers also benefits drivers who prefer the non-tolled option by freeing up capacity at the frontage road intersection. The northbound SH 130 to westbound 290E flyover opened in January 2019, the northbound SH 130 to westbound 290E flyover opened in January 2020, and the southbound SH 130 to eastbound 290E flyover opened in February 2021 and will be owned by TxDOT.

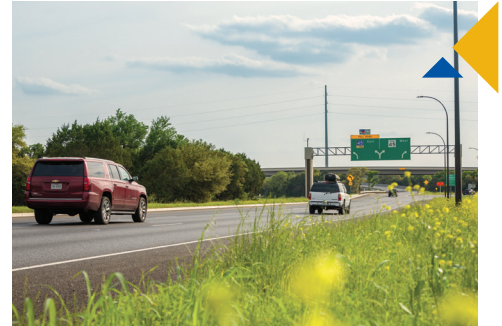
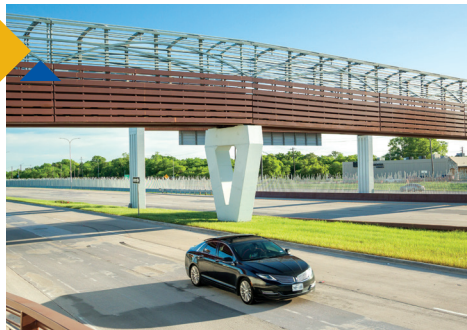
### 1.3.4. SH 45 SOUTHWEST

The Mobility Authority constructed, operates and maintains SH 45 Southwest, a tolled facility stretching 3.6 miles from State Loop 1 to FM 1626 in Southern Travis and Northern Hays counties. The corridor, which opened to traffic in June 2019, includes two tolled lanes in each direction, and was built without frontage roads to limit impacts to the surrounding environment. The road offers drivers an alternative to congested neighborhood streets like Menchaca Road, Slaughter Lane and Brodie Lane. The corridor also includes a 4.5-mile shared use path.

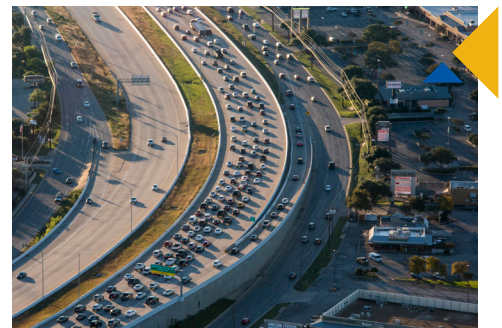
### 1.3.6. 183 NORTH MOBILITY PROJECT

The 183 North Mobility Project will include two express lanes in each direction along a 9-mile stretch of US 183 between State Highway (SH) 45 North/Ranch-to-Market (RM) 620 and State Loop 1 (MoPac), the addition of a fourth general-purpose lane to bring the total number to four in each direction, and express lane direct connectors to and from southbound MoPac. The project also includes operational improvements for the transition to MoPac, new shared use path connections, new sidewalks, and cross-street connections for bicycles/pedestrians. The Mobility Authority is in the process of procuring a design-build contractor for the project. Construction is expected to begin in 2021.
