CENTRAL TEXAS REGIONAL
MOBILITY AUTHORITY

2020 ANNUAL REPORT OF CONDITIONS

Subject: **2020 Annual Report of Conditions – 183A Turnpike, 290E, SH 71 Express, SH 45 Southwest, and 183 South Interim Build Roadways**

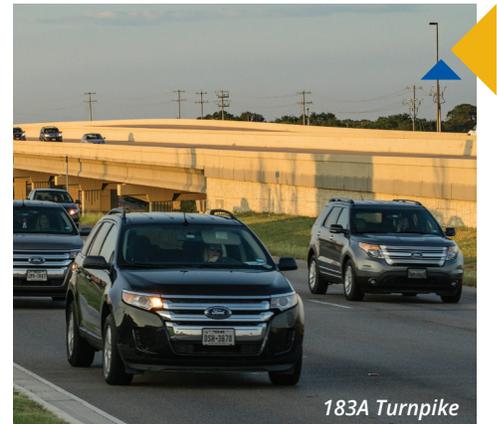
1.3.1. 183A TURNPIKE

The Mobility Authority constructed, operates and maintains the 183A Turnpike, a tolled facility stretching 10.4 miles from RM 620 to CR 276 in Williamson County. The all electronic toll collection corridor is a critical link in the highway network serving an area experiencing tremendous development and economic growth. The first phase of 183A Turnpike opened to traffic in March 2007, effectively reducing congestion, enhancing mobility, and providing safer travel. Phase II opened to traffic in April 2012 and included a 4.7-mile extension of the shared use path adjacent to the 183A Turnpike from RM 1431 to Hero Way, resulting in a significant shift of traffic from the non-tolled frontage roads to the new tolled mainlanes. In fall 2015, the intersection of 183A Turnpike and US 183 was reconstructed to make the intersection safer, easier to navigate and enable better access to developments along the 183A Turnpike corridor

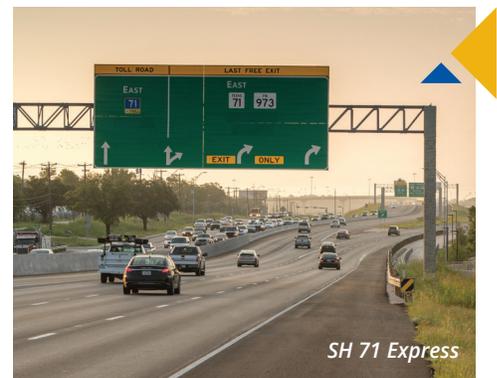
The Mobility Authority operates and maintains the SH 71 Express, which stretches approximately four miles eastward along SH 71 from Presidential Boulevard to east of SH 130 in Travis County. The project, constructed by TxDOT, added a toll lane in each direction along SH 71 and opened to traffic in February 2017.

The all electronic toll facility enhances traffic flow, mobility, and vehicle and pedestrian safety along SH 71, a key east-west corridor connecting drivers to the Austin-Bergstrom International Airport, the city of Bastrop, and points beyond. The project was designed to eliminate weaving and merging caused by airport-bound traffic exiting SH 71 while sharing the road with through-traffic. It also offers drivers an alternative to the long travel times caused by multiple traffic signals within the project limits. The new lanes offer a free-flowing and reliable bypass route for through-traffic, especially during peak hour congestion.

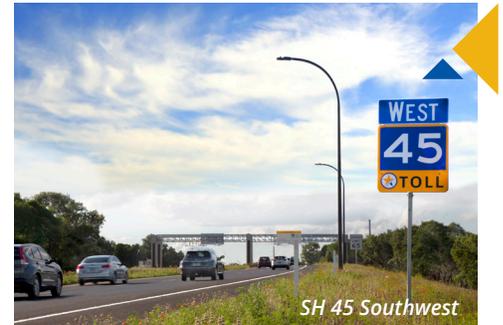
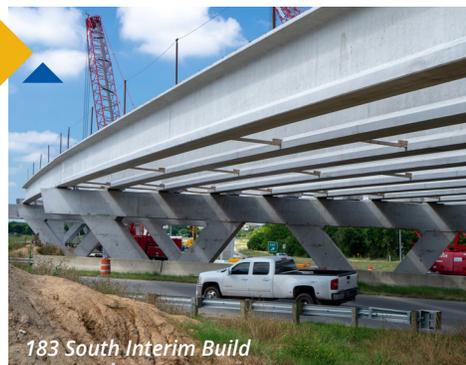
1.3.4. SH 45 SOUTHWEST

The Mobility Authority constructed, operates and maintains SH 45 Southwest, a tolled facility stretching 3.6 miles from State Loop 1 to FM 1626 in Southern Travis and Northern Hays County. The all electronic toll collection corridor, which opened to traffic in June 2019, includes two tolled lanes in each direction, and was built without frontage roads to limit impacts to the surrounding environment. The road offers drivers an alternative to congested neighborhood streets like Menchaca Road, Slaughter Lane and Brodie Lane.
