ANNUAL REPORT OF CONDITIONS

CENTRAL TEXAS REGIONAL
MOBILITY AUTHORITY

Subject: **2022 Annual Report of Conditions – 183A Turnpike, 290E, SH 71 Express, SH 45 Southwest, 183 South, 183 North Mobility Project**

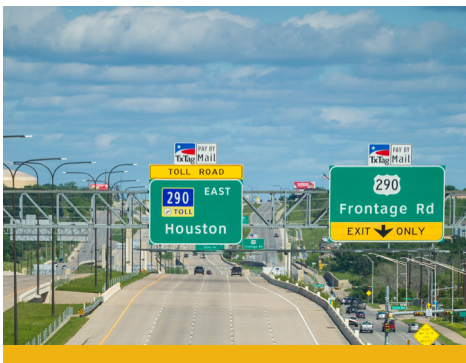
1.3.2. 290E

The Mobility Authority constructed, operates, and maintains the 290E, a 6.2-mile limited-access toll road along US 290 East, spanning from US 183 to just east of Parmer Lane. The corridor is a significant link to important roadways in the region including US 183, IH-35 and SH 130, and provides a critical evacuation route from the Gulf Coast region. The first phase of 290E, which consisted of four tolled direct connectors at the US 183 interchange, opened in December 2012. The second phase of the project opened to traffic in May 2014, effectively reducing congestion on US 290 East and bringing reliable travel times for tolled and non-tolled travel.

The Mobility Authority, in partnership with TxDOT, finished construction in 2021 of three new direct connector (DC) flyover bridges at the convergence of 290E and SH 130 to link the two facilities together. This gives drivers a safe, efficient, free-flowing direct connection between the two toll roads. The new flyovers also benefits drivers who prefer the non-tolled option by freeing up capacity at the frontage road intersection. The southbound SH 130 to westbound 290E flyover opened in January 2019, the northbound SH 130 to westbound 290E flyover opened in January 2020, and the eastbound 290E to southbound SH 130 flyover opened in February 2021 and is owned by TxDOT.

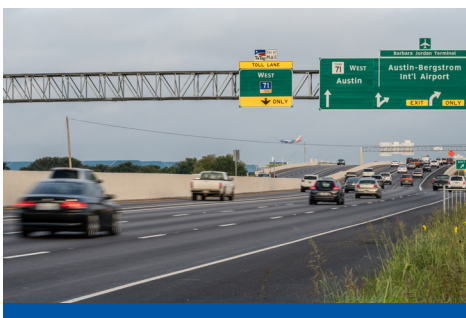
1.3.3. SH 71 EXPRESS

The Mobility Authority operates and maintains SH 71 Express, which stretches approximately 4 miles eastward along SH 71 from Presidential Boulevard to east of SH 130 in Travis County. The project, constructed by TxDOT, added a toll lane in each direction along SH 71 and opened to traffic in February 2017.

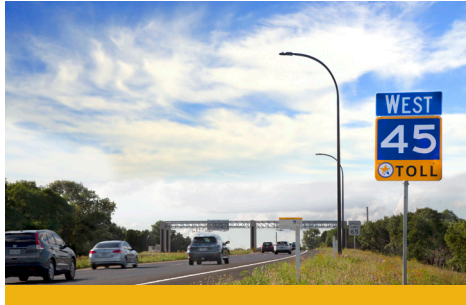
1.3.4. SH 45 SOUTHWEST

The Mobility Authority constructed, operates and maintains SH 45 Southwest, a tolled facility stretching 3.6 miles from State Loop 1 to FM 1626 in Southern Travis and Northern Hays counties. The corridor, which opened to traffic in June 2019, includes two tolled lanes in each direction, and was built without frontage roads to limit impacts to the surrounding environment. The road offers drivers an alternative to congested neighborhood streets like Menchaca Road, Slaughter Lane and Brodie Lane. The corridor also includes a 4.5-mile shared use path.

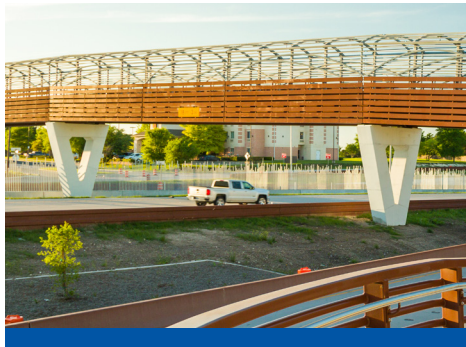
1.3.5. 183 SOUTH

The Mobility Authority constructed, operates, and maintains 183 South, a limited access toll road along US 183, spanning 8-miles from US 290 to SH 71. The project triples the corridor's previous capacity, adding three tolled lanes and rebuilding up to three non-tolled, general-purpose lanes in each direction, offering greater mobility for all users of the corridor. The Interim portion opened to traffic in 2019, and the remaining tolled sections opened in early 2021. Aesthetic enhancements are a major project component and are visible in the unique design of the bridges, walls, and other features. The project also includes amenities for active

transportation users, including continuous bicycle lanes, a shared use path, sidewalks, four pedestrian bridges, two major trailheads and several smaller trailheads.

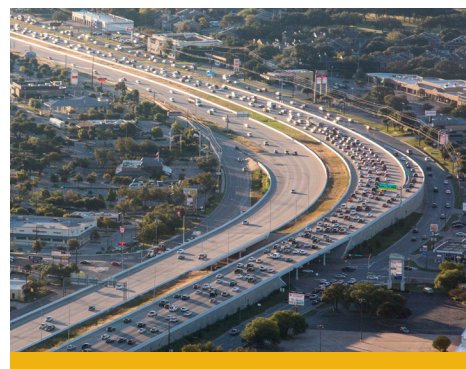
1.3.6. 183 NORTH MOBILITY PROJECT

The 183 North Mobility Project will include two express lanes in each direction along a 9-mile stretch of US 183 between State Highway (SH) 45 North/Ranch-to-Market (RM) 620 and State Loop 1 (MoPac), the addition of a fourth general-purpose lane to bring the total number to four in each direction, and express lane direct connectors to and from southbound MoPac. The project also includes operational improvements for the transition to MoPac, new shared use path connections, new sidewalks, and cross-street connections for bicycles/pedestrians. Construction is expected to begin in early 2022.
