2022

ANNUAL REPORT OF CONDITIONS

CENTRAL TEXAS REGIONAL
MOBILITY AUTHORITY

Subject: **2022 Annual Report of Conditions – 183A Turnpike, 290E, SH 71 Express, SH 45 Southwest, 183 South, 183 North Mobility Project**

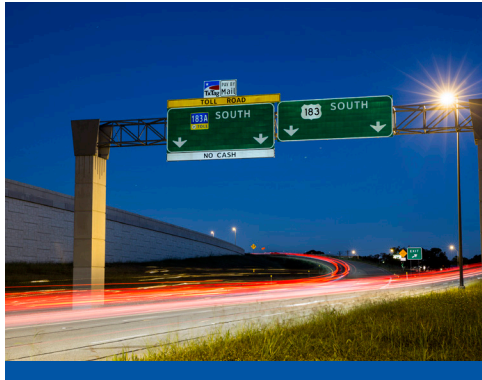
1.3.1. 183A TURNPIKE

The Mobility Authority constructed, operates and maintains the 183A Turnpike, a tolled facility stretching 10.4 miles from RM 620 to CR 276 in Williamson County. The corridor is a critical link in the highway network serving an area experiencing tremendous development and economic growth. The first phase of 183A Turnpike opened to traffic in March 2007, effectively reducing congestion, enhancing mobility, and providing safer travel. Phase II opened to traffic in April 2012 and included a 4.7-mile extension of the shared use path adjacent to the 183A Turnpike from RM 1431 to Hero Way, resulting in a significant shift of traffic from the non-tolled frontage roads to the new tolled mainlanes. In fall 2015, the intersection of 183A Turnpike and US 183 was reconstructed to make the intersection safer, easier to navigate and to enable better access to developments along the 183A Turnpike corridor. The third phase of the 183A Turnpike has been designed and developed. Construction of the 183A Phase III Project began in 2021. The new 6.6-mile roadway will extend the existing 183A Turnpike corridor northward from Hero Way to 1.1 miles north of SH 29 and provide two tolled lanes in each direction, within the existing TxDOT and Mobility Authority right-of-way and within the median of the existing US 183 corridor.

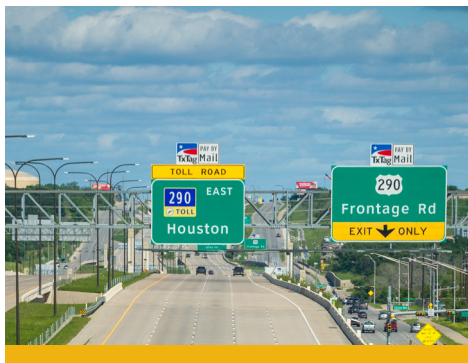
1.3.2. 290E

The Mobility Authority constructed, operates, and maintains the 290E, a 6.2-mile limited-access toll road along US 290 East, spanning from US 183 to just east of Parmer Lane. The corridor is a significant link to important roadways in the region including US 183, IH-35 and SH 130, and provides a critical evacuation route from the Gulf Coast region. The first phase of 290E, which consisted of four tolled direct connectors at the US 183 interchange, opened in December 2012. The second phase of the project opened to traffic in May 2014, effectively reducing congestion on US 290 East and bringing reliable travel times for tolled and non-tolled travel.

The Mobility Authority, in partnership with TxDOT, finished construction in 2021 of three new direct connector (DC) flyover bridges at the convergence of 290E and SH 130 to link the two facilities together. This gives drivers a safe, efficient, free-flowing direct connection between the two toll roads. The new flyovers also benefits drivers who prefer the non-tolled option by freeing up capacity at the frontage road intersection. The southbound SH 130 to westbound 290E flyover opened in January 2019, the northbound SH 130 to westbound 290E flyover opened in January 2020, and the eastbound 290E to southbound SH 130 flyover opened in February 2021 and is owned by TxDOT.

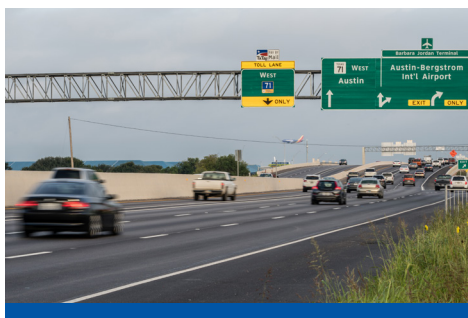
1.3.3. SH 71 EXPRESS

The Mobility Authority operates and maintains SH 71 Express, which stretches approximately 4 miles eastward along SH 71 from Presidential Boulevard to east of SH 130 in Travis County. The project, constructed by TxDOT, added a toll lane in each direction along SH 71 and opened to traffic in February 2017.

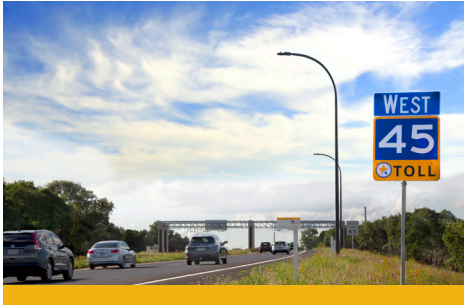
1.3.4. SH 45 SOUTHWEST

The Mobility Authority constructed, operates and maintains SH 45 Southwest, a tolled facility stretching 3.6 miles from State Loop 1 to FM 1626 in Southern Travis and Northern Hays counties. The corridor, which opened to traffic in June 2019, includes two tolled lanes in each direction, and was built without frontage roads to limit impacts to the surrounding environment. The road offers drivers an alternative to congested neighborhood streets like Menchaca Road, Slaughter Lane and Brodie Lane. The corridor also includes a 4.5-mile shared use path.

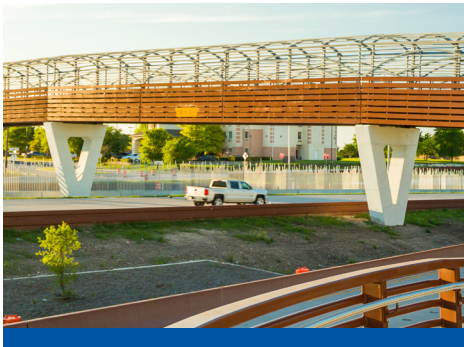
1.3.5. 183 SOUTH

The Mobility Authority constructed, operates, and maintains 183 South, a limited access toll road along US 183, spanning 8-miles from US 290 to SH 71. The project triples the corridor's previous capacity, adding three tolled lanes and rebuilding up to three non-tolled, general-purpose lanes in each direction, offering greater mobility for all users of the corridor. The Interim portion opened to traffic in 2019, and the remaining tolled sections opened in early 2021. Aesthetic enhancements are a major project component and are visible in the unique design of the bridges, walls, and other features. The project also includes amenities for active

transportation users, including continuous bicycle lanes, a shared use path, sidewalks, four pedestrian bridges, two major trailheads and several smaller trailheads.

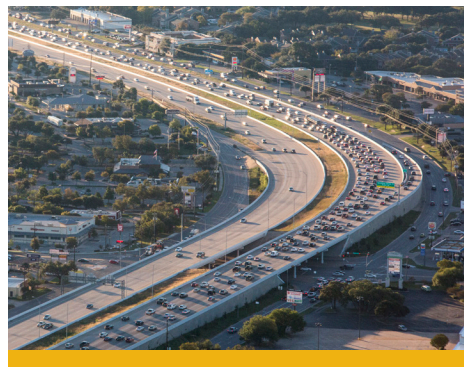
1.3.6. 183 NORTH MOBILITY PROJECT

The 183 North Mobility Project will include two express lanes in each direction along a 9-mile stretch of US 183 between State Highway (SH) 45 North/Ranch-to-Market (RM) 620 and State Loop 1 (MoPac), the addition of a fourth general-purpose lane to bring the total number to four in each direction, and express lane direct connectors to and from southbound MoPac. The project also includes operational improvements for the transition to MoPac, new shared use path connections, new sidewalks, and cross-street connections for bicycles/pedestrians. Construction is expected to begin in early 2022.
